GOLDEN GATE HOME INSPECTIONS

HOME INSPECTION REPORT

1234 Main St. El Cerrito CA 94530

12/13/2020 9:00AM

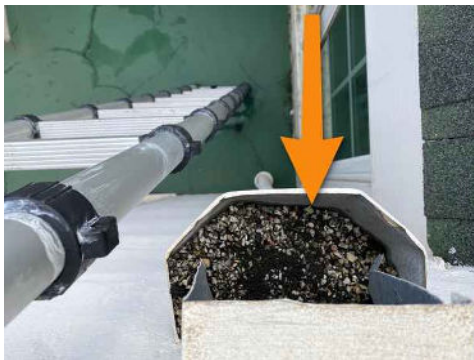
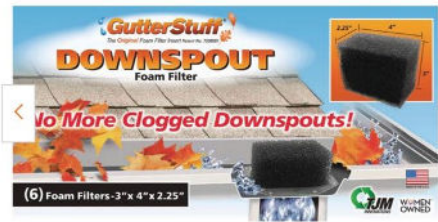
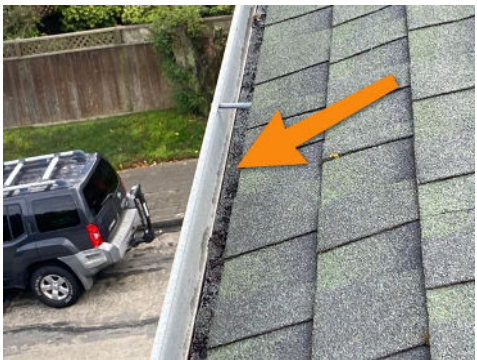
2.4.1 Roof Drainage Systems

DEBRIS

Accumulated debris at gutters and/or scuppers noted. We recommend removing debris to ensure proper drainage of the roofing system and to prevent moisture damage. This scupper filter may help to keep gravel out of system.

Contact a qualified gutter contractor

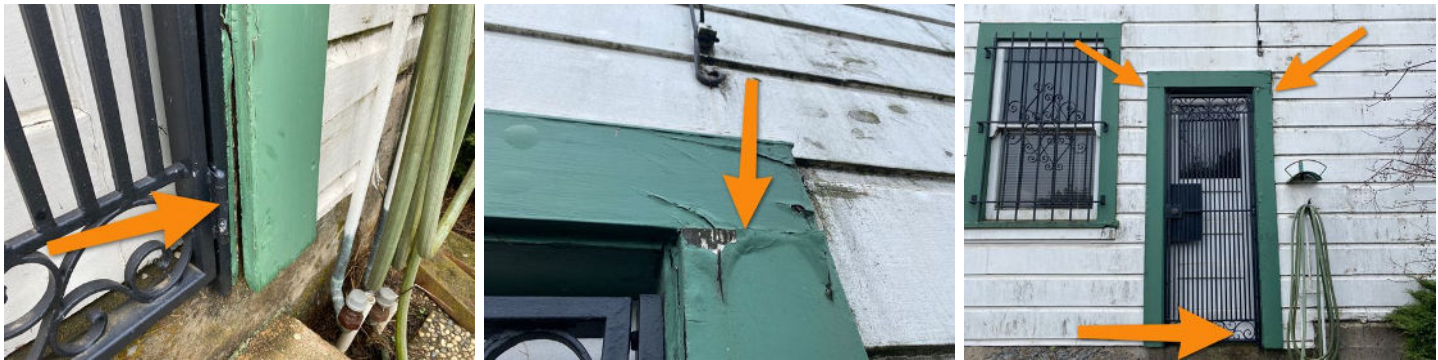
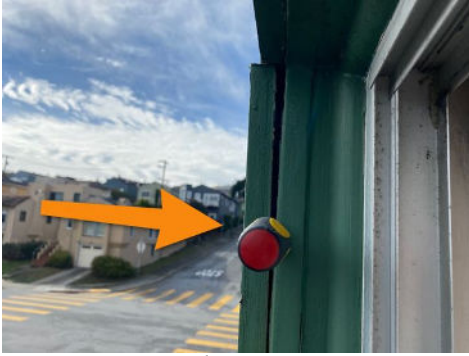
3.2.1 Exterior Doors

SEPARATION AT TRIM-TO-TRIM CONNECTIONS

REAR EXTERIOR DOOR

Separations at trim-to-trim connections noted. Recommend sealing these trim connections to prevent moisture intrusions.

Contact a qualified general contractor.

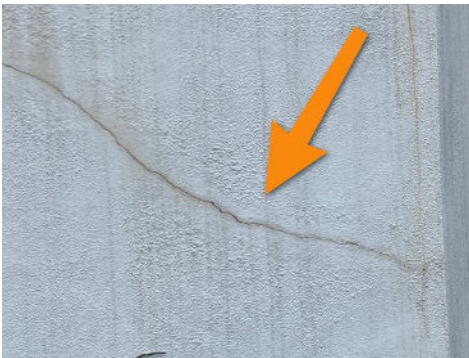
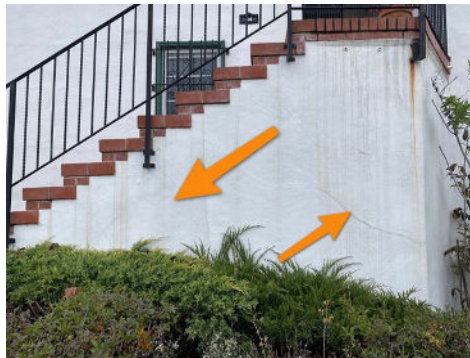
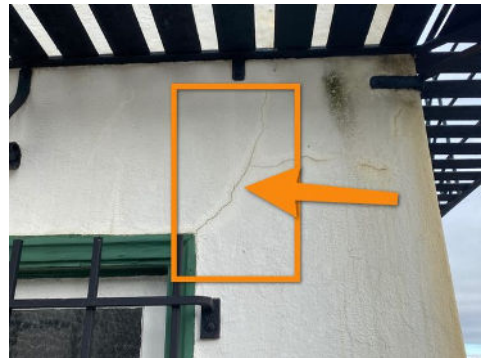
3.3.1 Siding, Flashing & Trim

CRACKING AND MICRO-CRACKING IN STUCCO

Cracking and micro-cracking of the stucco exterior surface noted. This can lead to moisture intrusion, further deterioration of the stucco exterior, and structural framing beneath. We recommend contacting a stucco contractor for repair.

Contact a qualified general contractor.

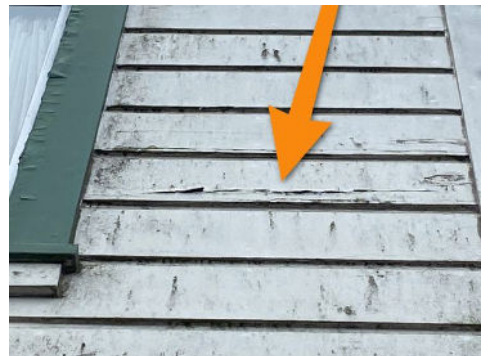
3.3.2 Siding, Flashing & Trim

CRACKING, CHIPPED, & MISSING PAINT

REAR EXTERIOR

Chipped and missing paint at the exterior siding noted. We recommend having any missing or chipped paint repainted, any gaps in the siding and trim connections properly sealed, and any damaged wood replaced. This helps to prevent water intrusion and ensure the full waterproofing envelope of the exterior.

Contact a qualified general contractor.

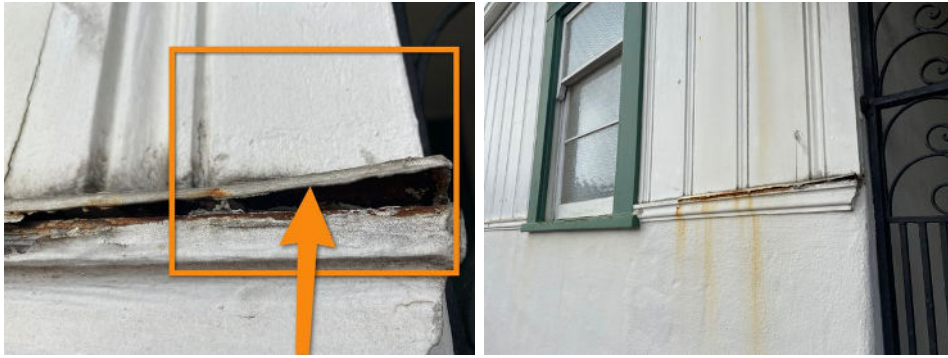
3.3.3 Siding, Flashing & Trim

FLASHING/TRIM COMPROMISED

Improperly installed, missing flashing, or trim pieces noted. This could result in moisture intrusion and potential damaging leaks. We recommend contacting a general contractor for repair or recommendation.

Contact a qualified general contractor.

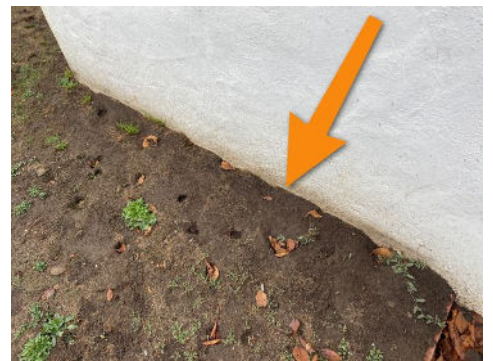
3.3.4 Siding, Flashing & Trim

STUCCO TO EARTH CONTACT

Stucco to ground contact noted. This practice was a standard years ago and has since changed to a metal screed at the lower edge to allow moisture to escape. Stucco to earth contact holds moisture and damages surface. Consider having a stucco contractor repair or to keep 6" clearance between stucco and dirt.

Contact a stucco repair contractor

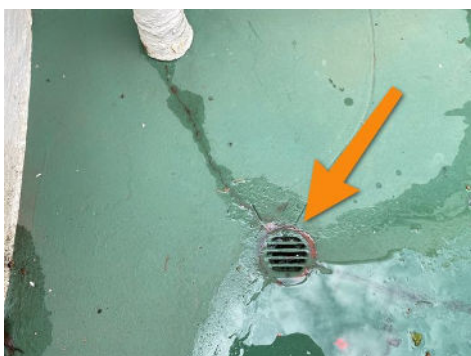
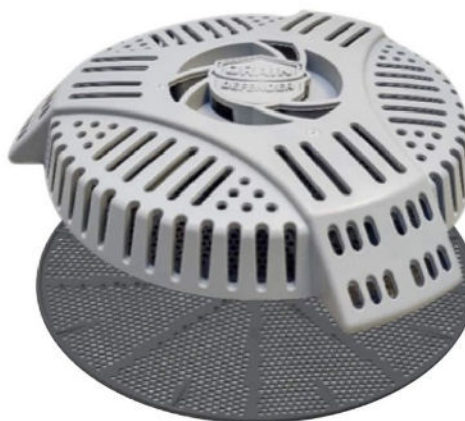
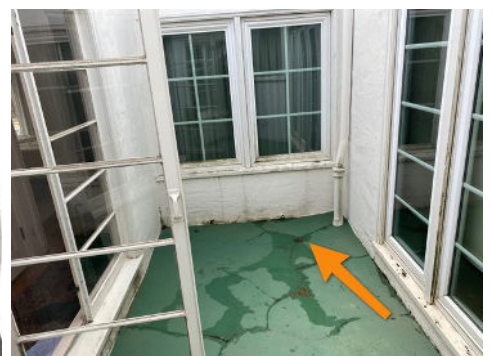
3.6.1 Decks, Balconies, Porches & Steps

DRAIN INSUFFICIENT

Patio courtyard is said to have insufficient drainage and too clog easily. We recommend the installation of a two cycle filtration drain cover. (see picture) Contact a general contractor for recommendation and service.

Contact a qualified general contractor.

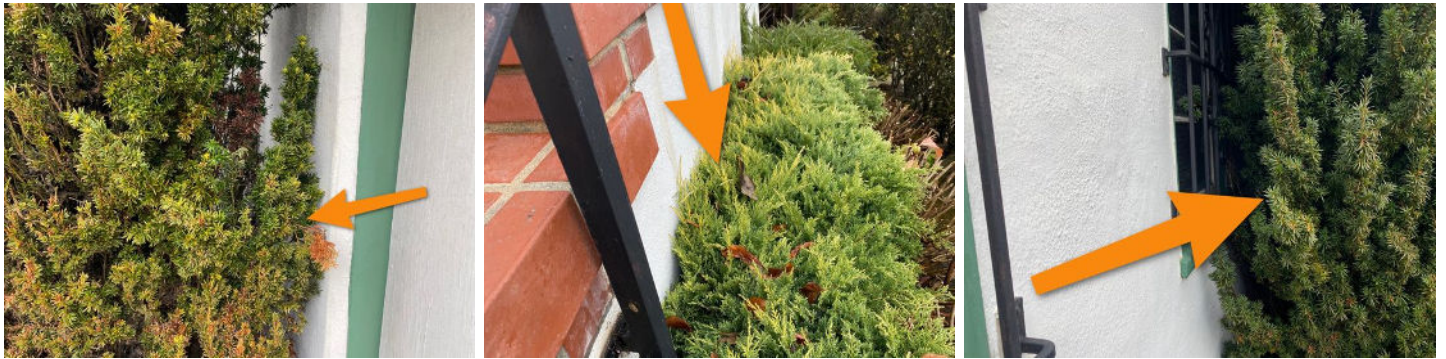
3.7.1 Vegetation, Grading, Drainage & Retaining Walls

VEGETATION TOUCHING HOUSE

LEFT EXTERIOR

Vegetation touching house noted. This can damage siding, invite moisture, and insects into the structure. Small bushes and plants should be trimmed approximately 8" away from the building, and any vines on exterior removed.

Contact a qualified landscaping contractor

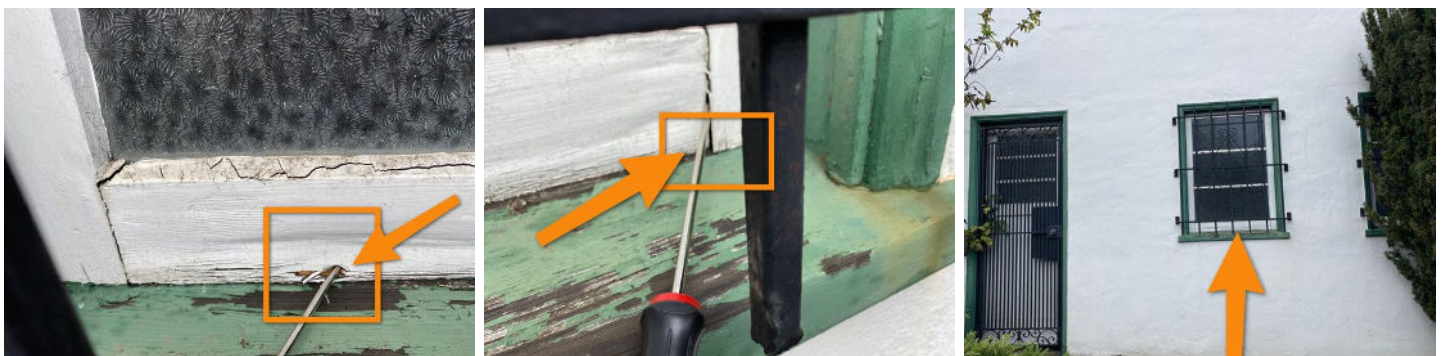
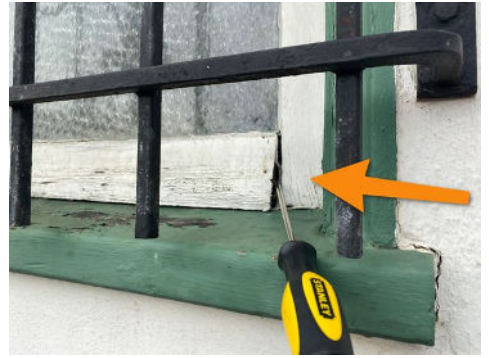
3.8.1 Windows

DRY ROT

Dry rot at visible portions of the exterior windows were noted. Recommend all wood with dry rot be replaced by a licensed professional. It is important to replace dry rotted wood to prevent spread of dry rot and to ensure the full waterproofing envelope of the exterior. Dry rotted wood is also known to invite wood eating insects. Areas of improperly installed or missing house wrap around windows is noted. Housewrap is an essential part of the exterior weatherproofing envelope. Missing housewrap, improperly installed siding, and dry rot and moisture damage at the windows are all connected systems. Improperly installed or damaged siding and improperly installed or missing house wrap should be corrected to prevent further damage to windows.

Front ground level

Contact a qualified general contractor.

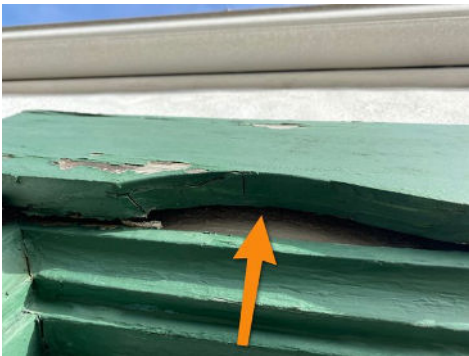
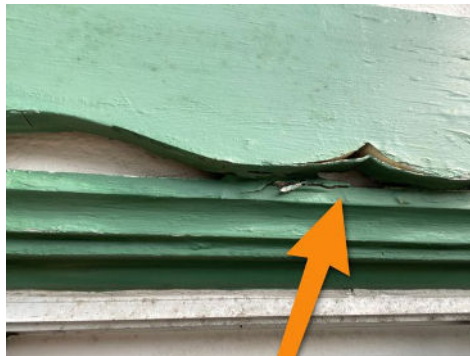
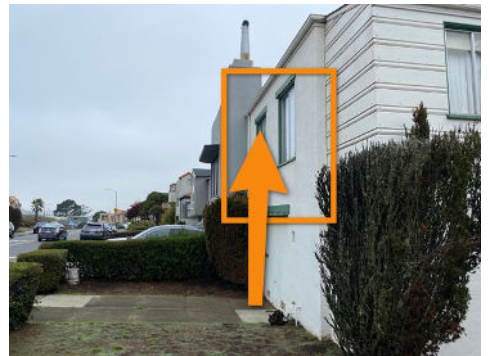
3.8.2 Windows

SEPARATIONS AT SIDING-TO-TRIM CONNECTIONS

Separations at siding to window trim connections was noted. This can allow moisture intrusion and cause further damage to the siding. Recommend sealing with exterior grade sealant and following proper surface preparation techniques. Allow for adequate time for the sealant to cure, prime, and paint.

Contact a qualified general contractor.

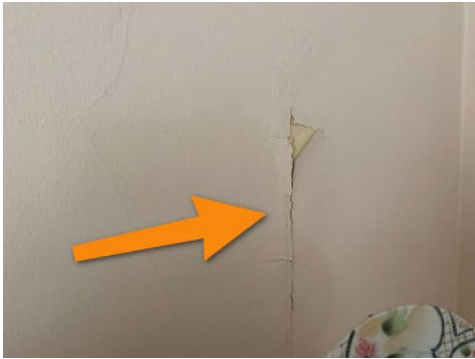
4.2.1 Walls

GENERAL DAMAGE

General damage to walls was noted in the living room of the home. Recommend cleaning patching and painting. We recommend contacting a painting contractor and drywall contractor for recommendations and repair.

Contact a qualified professional.

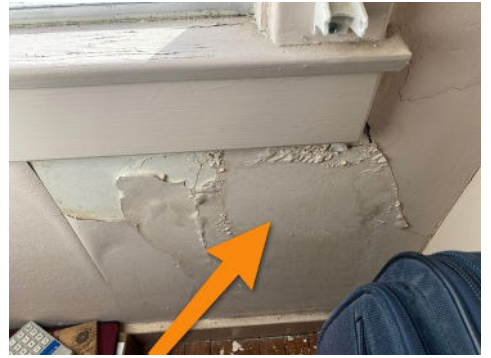
4.2.2 Walls

MOISTURE DAMAGE

Stains on wall materials from moisture intrusion were noted. We recommend ensuring source of moisture intrusion is corrected and contacting a qualified contractor for repair.

Contact a qualified general contractor.

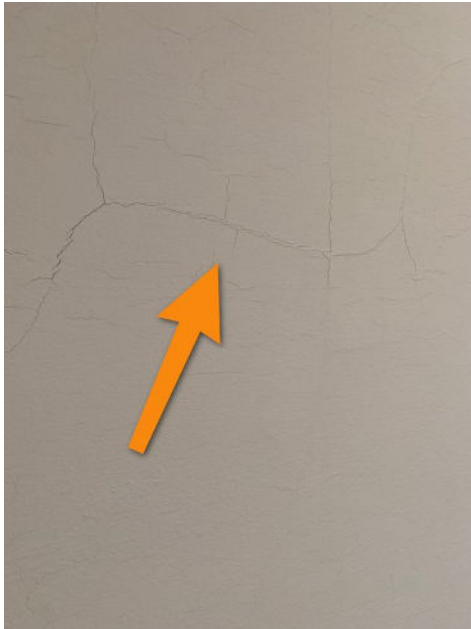
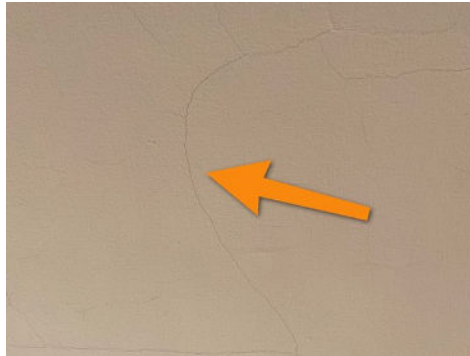
4.3.1 Ceilings

SETTLING CRACKS

Common settling cracks in wall and ceiling materials that appear to be the result of long-term settling were noted. Recommend monitoring cracks. Contact painting contractor for service or repair.

Contact a qualified painting contractor.

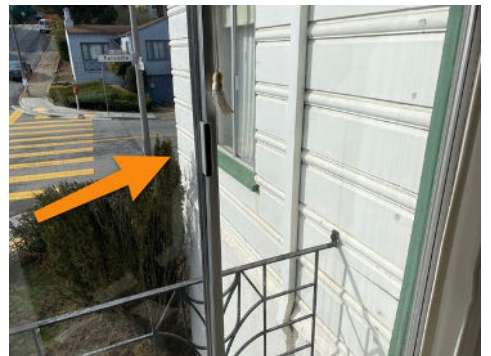
4.6.1 Windows

DIFFICULT TO OPEN

Two windows in the living room were difficult to open and close. With the use of force to open or close windows there's a possibility of breaking glass pane. We recommend cleaning and lubricating metal hinges. If this doesn't remedy the problem contacting a window repair specialist.

Contact a qualified window repair/installation contractor.

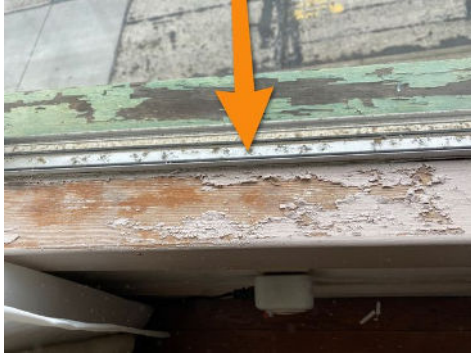
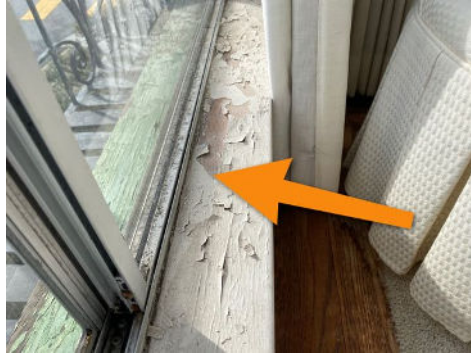
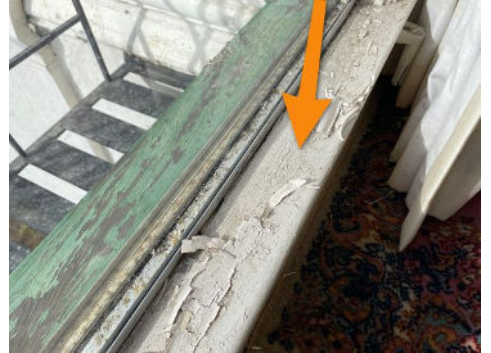
4.6.2 Windows

WINDOW SILL DAMAGE

Window sill damage noted. Either sun or moisture damage may be the cause, these are recommended to be repaired. Contact general contractor for service.

Contact a qualified general contractor.

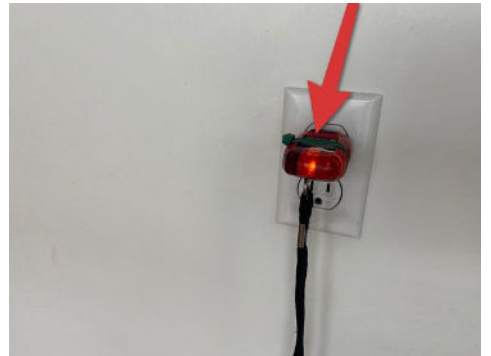
4.7.1 Electrical

UNGROUND 3 PRONG RECEPTACLES

Ungrounded 3 prong receptacles around home noted. This gives a false sense of security. Recommend upgrading to grounded wiring or installing 2 prong outlets. Contact electrical contractor for repair.

Contact a qualified electrical contractor.

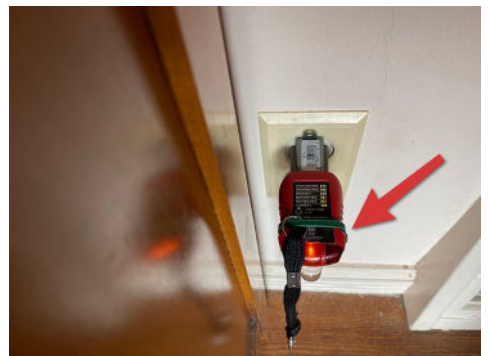
4.7.2 Electrical

UNGROUND OUTLETS

Ungrounded electrical outlets were found throughout the home at the time of the inspection. We recommend contacting an electrical contractor for recommendations on upgrading to 3 prong grounded outlets.

Contact a qualified electrical contractor.

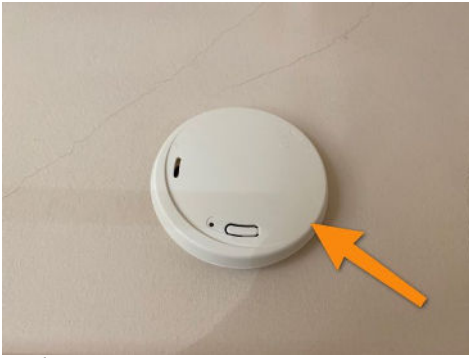
4.8.1 Smoke & Carbon Monoxide Detectors

BATTERIES

Recommend changing batteries for all smoke and carbon monoxide detectors in the home yearly to protect occupants.

Contact a qualified professional.

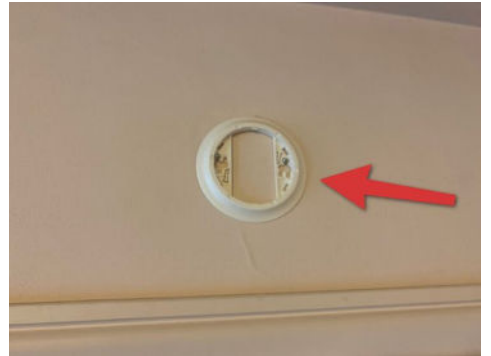
4.8.2 Smoke & Carbon Monoxide Detectors

MISSING SMOKE DETECTORS

One or more missing smoke detectors throughout the home noted. This is a life safety hazard. We recommend replacing.

Contact a qualified fire suppression contractor.

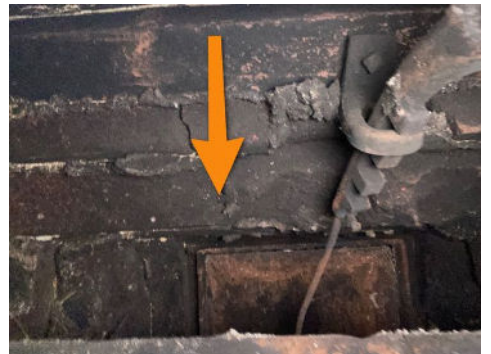
4.9.1 Fireplace

RECOMMEND CLEANING

Fireplace appears dirty under unit. Recommend servicing unit for proper function. Contact fireplace contractor for service.

Contact a qualified fireplace contractor.

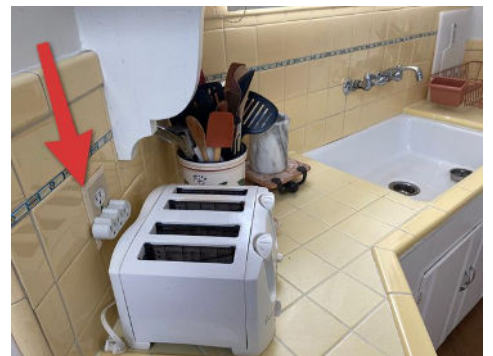
5.4.1 GFCI

GFCI PROTECTION NOT INSTALLED

GFCI protection not installed. GFCI's must be installed within 6 feet of all water sources. This is a life safety hazard. We recommend contacting an electrical contractor for service.

Contact a qualified electrical contractor.

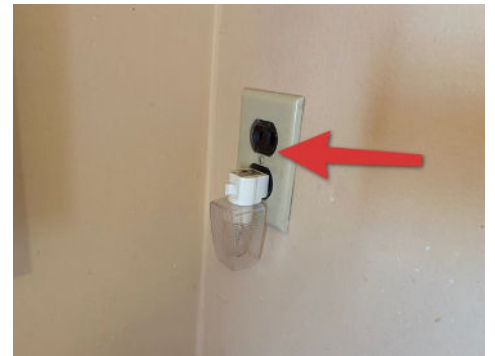
No GFCI protection at one or more bathroom receptacles was noted. GFCI's must be installed within 6 feet of all water sources. This is a life safety hazard. We recommend contacting electrical contractor for service.

Contact a qualified electrical contractor.

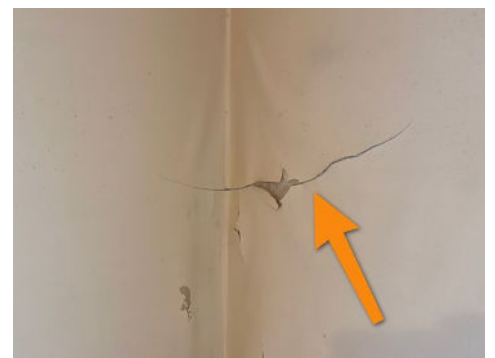
6.10.1 Walls

CRACKING

Visible cracking in walls is noted. Cracks appear to be from long term structural settling or from moisture intrusion. Recommend monitoring cracks. If further cracking persists, contact a licensed general contractor.

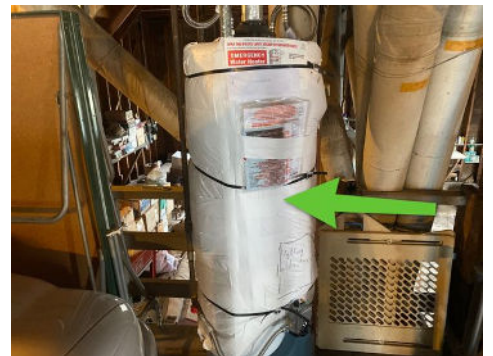
INACCESSIBLE

Water heaters inaccessible or covered over at the time of our inspection and could not be fully inspected. Contact plumbing contractor for further recommendation or service.

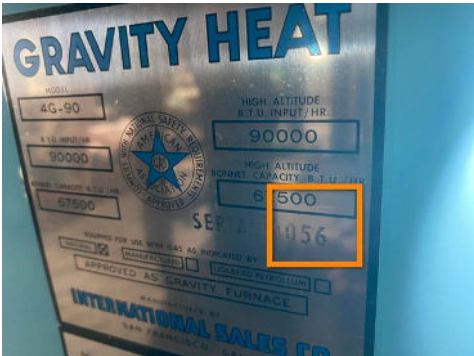
Gas furnace was operational at the time of our inspection, but it appears to be beyond its normal useful life. Contact HVAC contractor for further recommendation or service.

Recommendation
Contact a qualified HVAC professional.

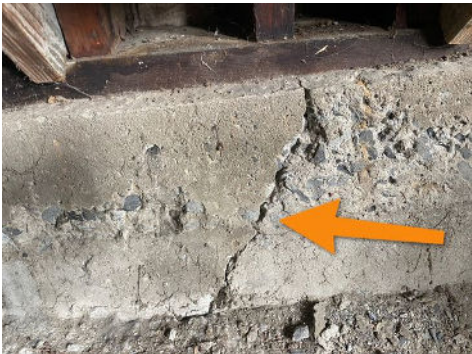
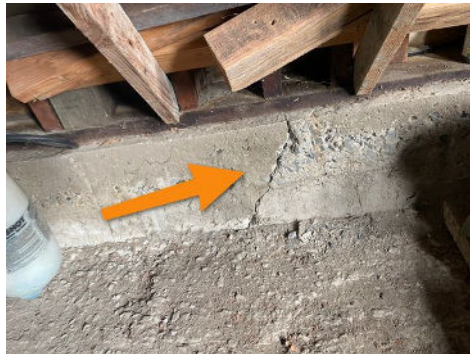
11.2.1 Foundation

CRACKING - MINOR

Minor visible cracking in the concrete foundation noted. Monitoring of this is recommended over time to evaluate further movement. If further cracking persists, we recommend contacting a structural engineer for causes and recommendations to repair.

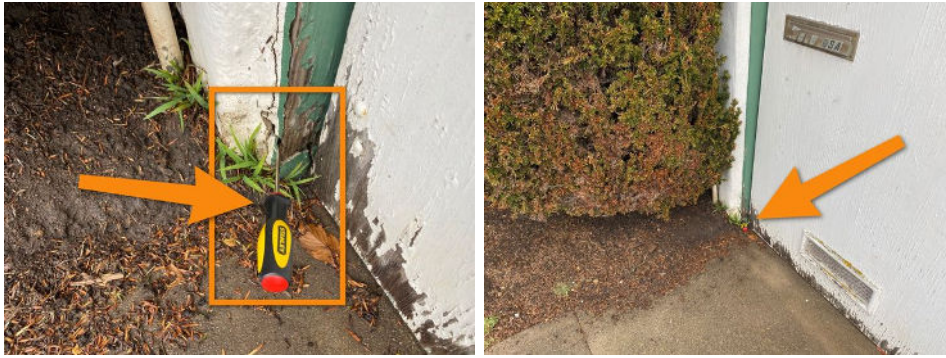
12.2.1 Garage Door
DRY ROT

Dry rot at overhead garage door is noted. Recommend repairing to prevent further damage. Contact garage door contractor for further recommendation or service.

Contact a qualified general contractor.

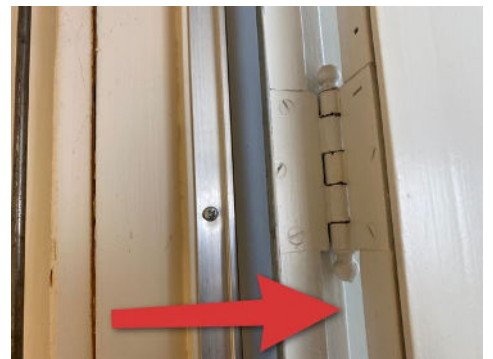
12.5.1 Occupant Door (From garage to inside of home)

Doors to garage must be fire rated for 20 minute burn time, sealed to habitable space, and self closing. We recommend contacting a door repair contractor for recommendations and service.

Contact a qualified door repair/installation contractor.

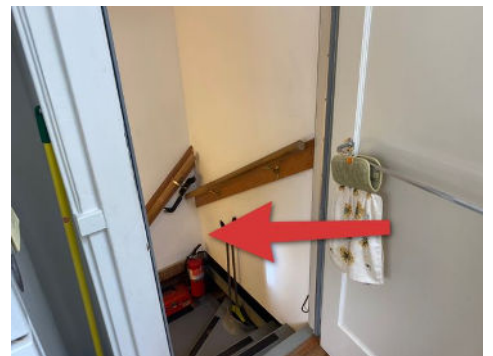
12.5.2 Occupant Door (From garage to inside of home)

Door from garage/basement to home, not self-closing, noted. The door was missing functional self-closing hinges, which help to prevent the spread of fire to living space. We recommend contacting a door repair and installation contractor for further recommendation or service.

Contact a qualified general contractor.

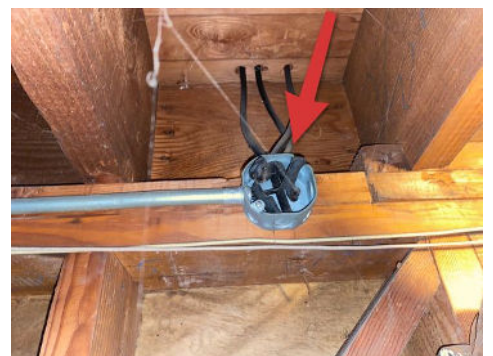
12.6.1 Receptacles

Open junction boxes noted in the garage. Recommend appropriate covering be installed. Contact a licensed electrical contractor for service.

Contact a qualified electrical contractor.

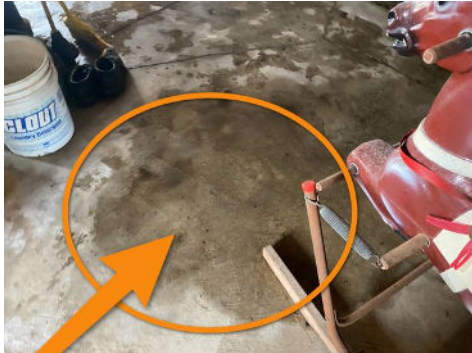
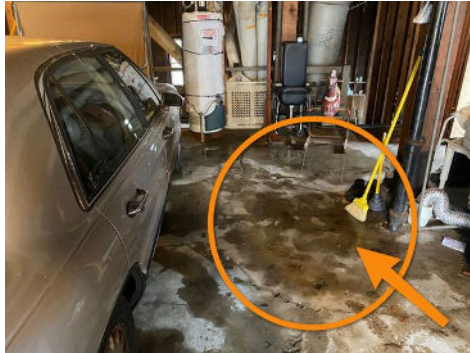
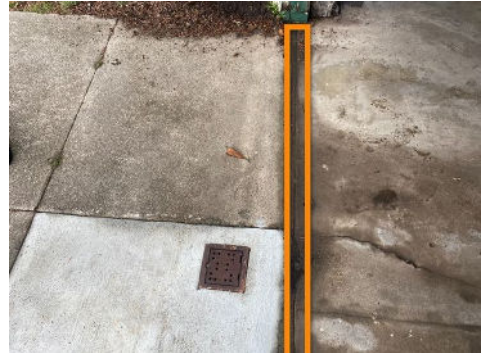
12.7.1 Floor

PONDING

Ponding was noted on garage floor.

We recommend the installation of a channel type drain that spans the width of the driveway.

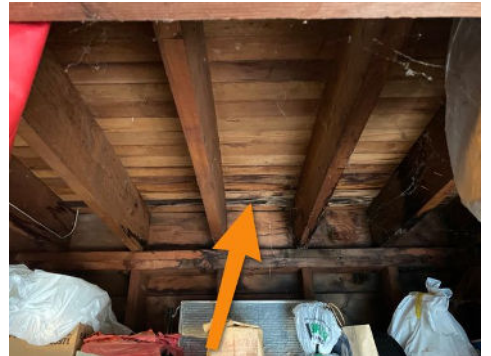
12.8.1 Ceiling

MOISTURE INTRUSION

Garage ceiling shows signs of moisture intrusion. To prevent further damage or growth of mold, we recommend a qualified contractor address and eliminate the source of moisture intuition. Certain types of mold are a life safety hazard. Contact general contractor for further recommendation or service.
