# HOME INSPECTION REPORT

1234 Main Street San Francisco, CA 94111

**Type of Building** Commercial Space

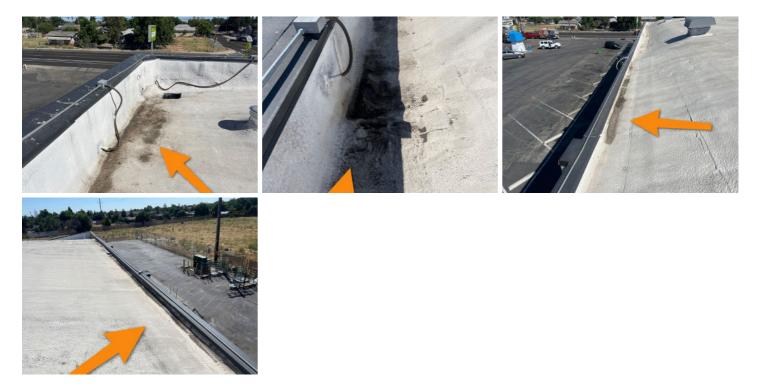
#### 2.2.1 Coverings

### **PONDING/NEGATIVE SLOPE**

Evidence of ponding in an area of the roof was noted. Ponding can lead to accelerated erosion and deterioration. We recommend adjustment of the slope of the roof at the time re-roofing activities occur.

Contact a qualified roofing professional.

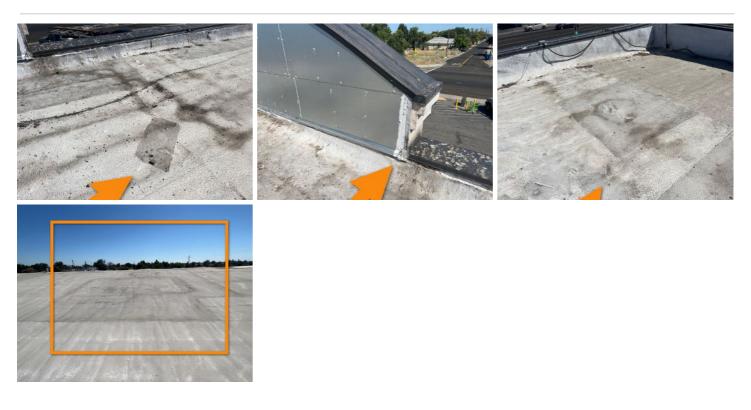
2.2.2 Coverings

# PATCHING

Patching at areas of roof material noted. Monitor these areas for leaks. If leaking occurs, contact a roofing contractor for further recommendations or service.

Recommendation Contact a qualified roofing professional.

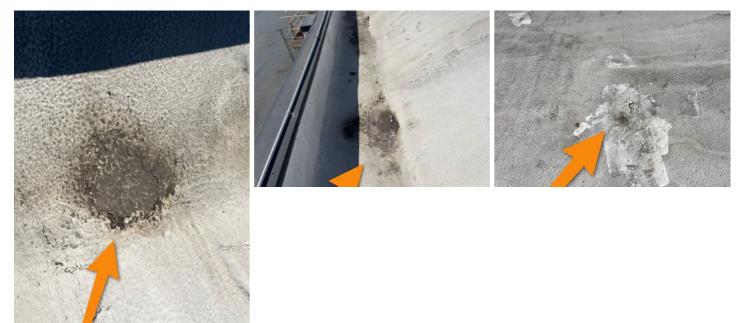
#### 2.2.3 Coverings ELASTOMERIC PEELING

The elastomeric roof coating was peeling at the time of inspection. ability This can allow moisture under the surface, which could possibly find entry to the structure. It is recommended that these areas or the entire roof system be repaired in order to preserve the waterproofing membrane of the roofing system.

Contact a qualified roofing professional.

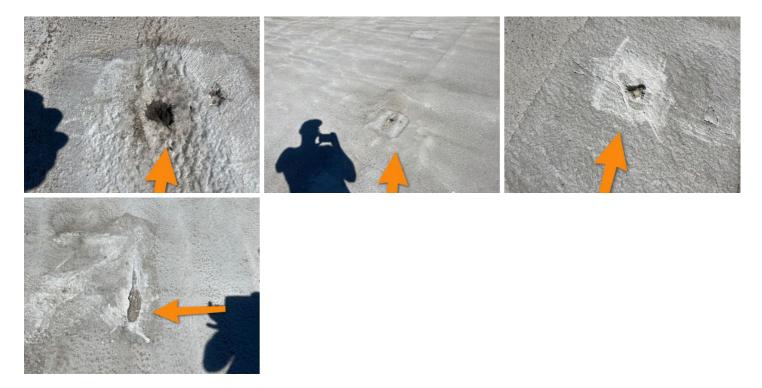
#### 2.2.4 Coverings

# HOLES

Holes noted in the roofing material. Contact roofing contractor for repair.

Contact a qualified roofing professional.

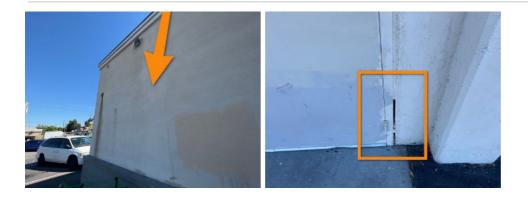
**Right exterior**

#### 3.2.2 Siding, Flashing & Trim CRACKING/GAPS IN SIDING

One or more areas of cracking and/or gaps in siding were noted. This should be properly sealed to prevent moisture intrusion to the interior of the building and deterioration of the waterproofing membrane of the exterior.

Contact a qualified general contractor.

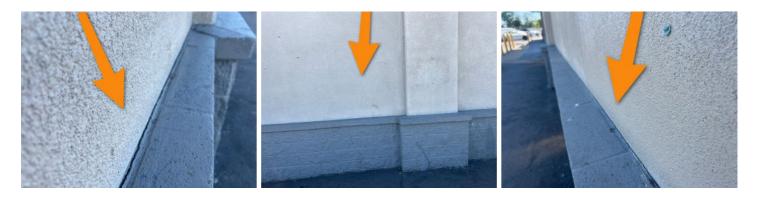
#### 3.2.3 Siding, Flashing & Trim

### GAPS AT MASONRY LEDGE

Gaps at the masonry ledge were noted. This should be properly sealed to prevent moisture intrusion and further damage to the structure inside these ledges.

Contact a qualified general contractor.

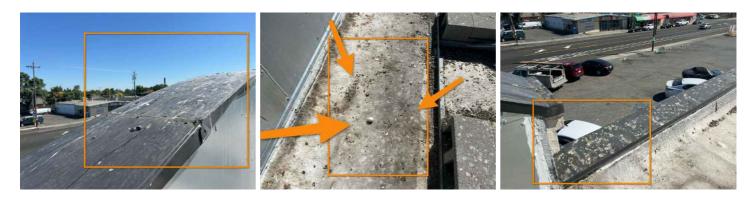
#### 3.3.1 Eaves, Soffits & Fascia

### **BIRD ACTIVITY**

Pigeon activity was noted throughout the property. We recommend contacting a pest control contractor to avoid damage to the building.

Contact a qualified pest control specialist.

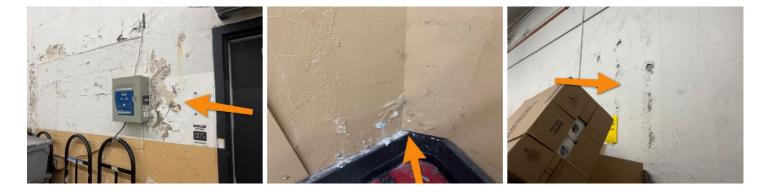
#### 4.2.1 Walls

#### **PAINT BUBBLING & CRACKING**

Visible bubbling a d cracking at the wall was noted. The area appeared dry, however, the loss of adhesion between the paint film and surface could be caused by the change in the temperature and humidity causing the room to reach high moisture levels. We recommend contacting a painting contractor for further evaluation.

Contact a qualified painting contractor.

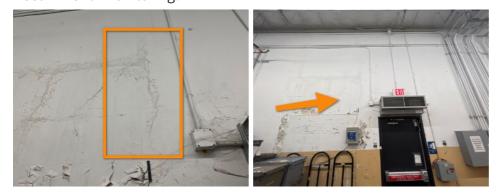
#### 11.1.1 Foundation **CRACKING - MINOR**

Areas of minor visible cracking (1/4-inch or less) on the concrete foundation were noted. This is likely due to concrete shrinkage or settling after the initial pour. Monitoring of this is recommended over time to evaluate further movement. If further cracking persists, we recommend contacting a structural engineer for causes and recommendations to repair.

#### Recommendation Recommend monitoring.
