GOLDEN GATE HOME INSPECTIONS

HOME INSPECTION REPORT

1234 Main Street
San Francisco, CA 94111

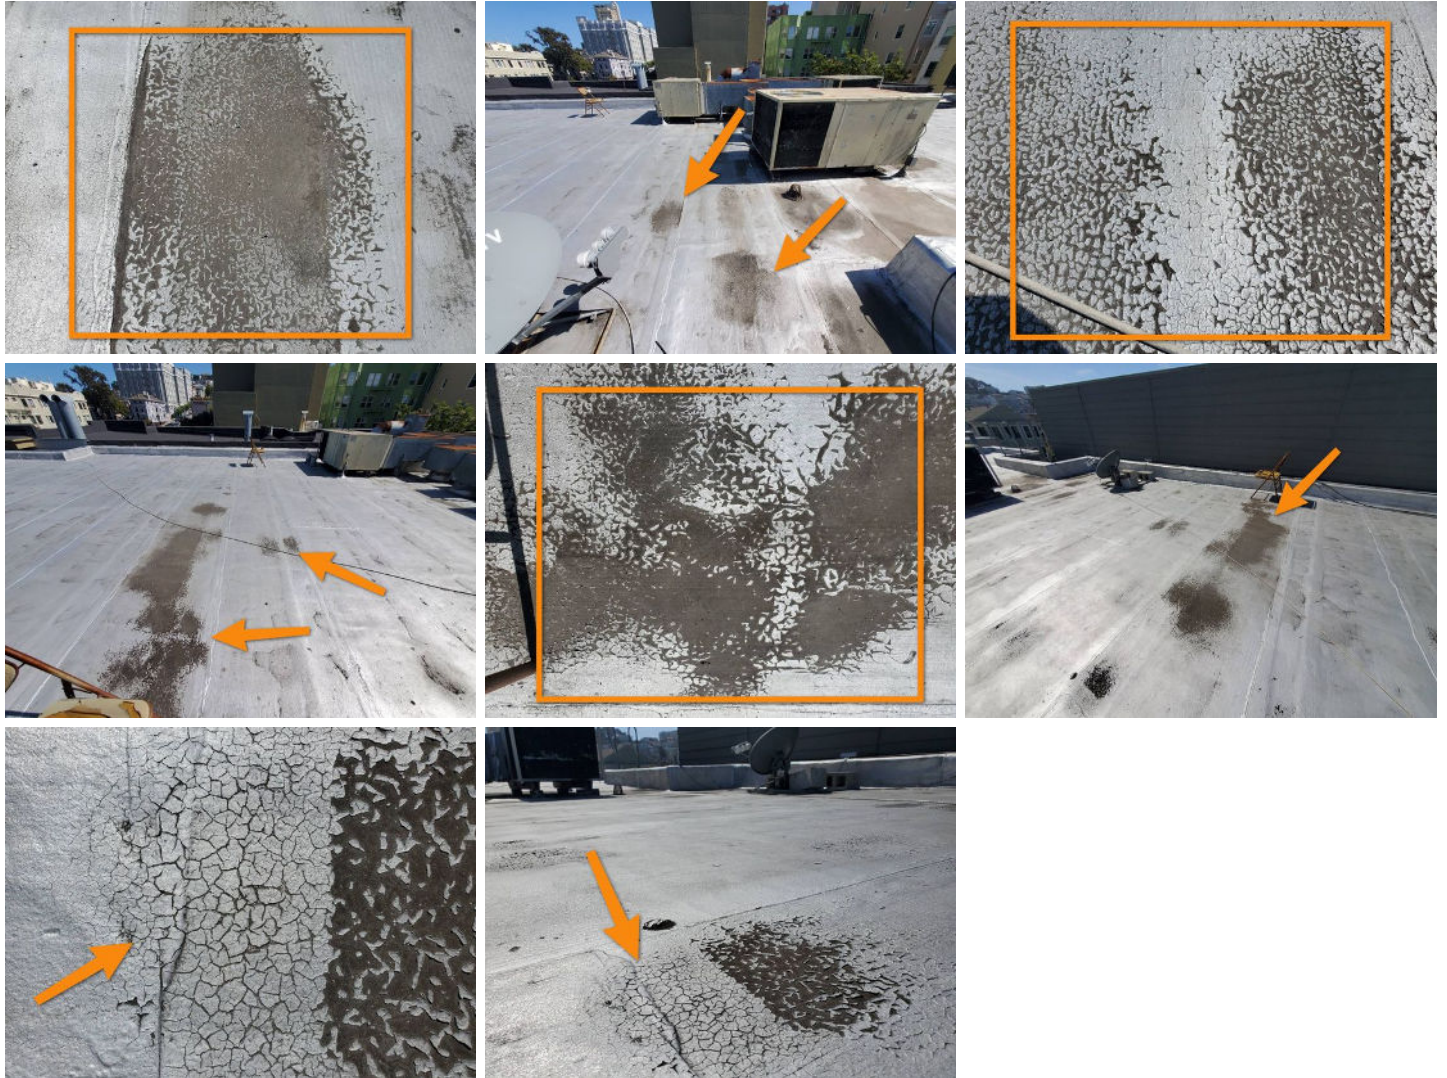
Elastomeric roof coating on the surface is peeling and cracking. This has the ability to allow moisture under the surface, which could possibly find entry into the home. A coating of aluminum asphalt paint is suggested to be applied for protection against ultraviolet rays every 3-5 years. This could lead to future moisture intrusion into the interior. We recommend contacting a roofing contractor for recommendation and service.

Contact a qualified roofing professional.

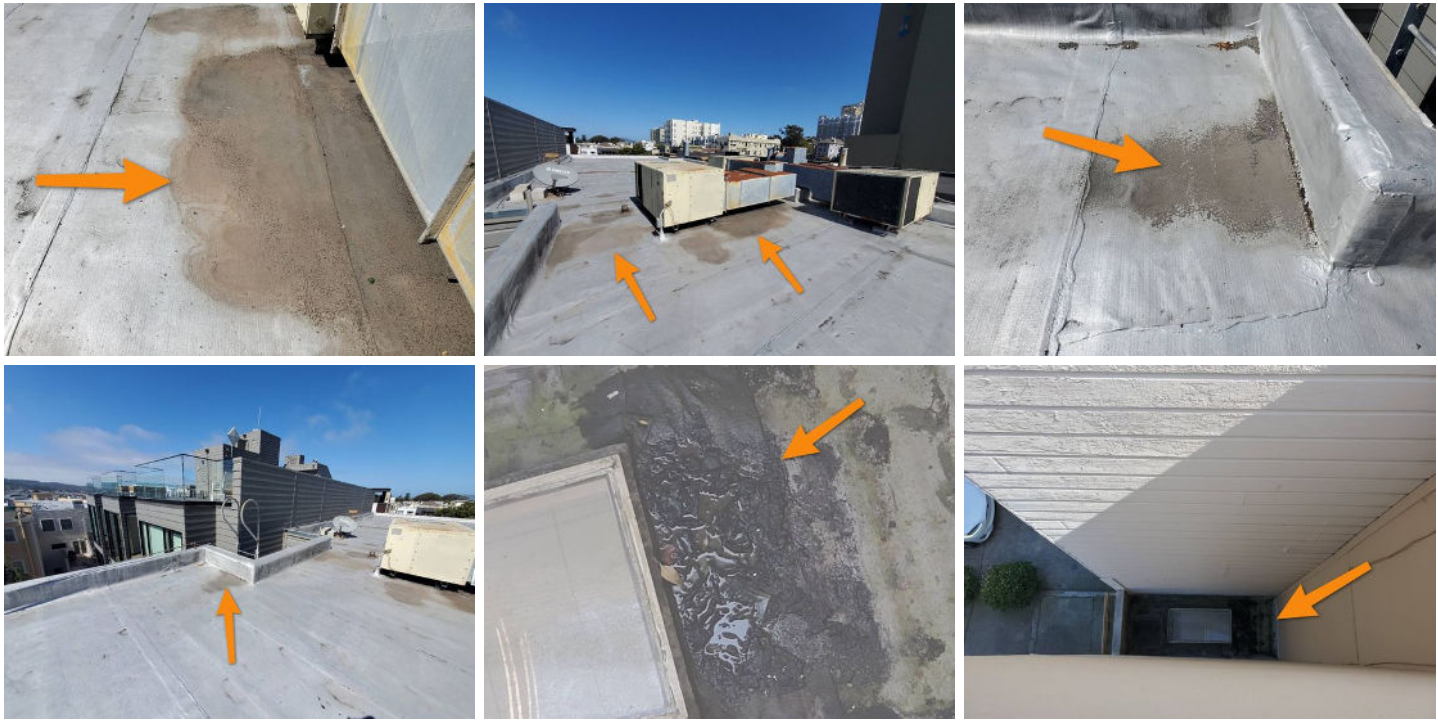
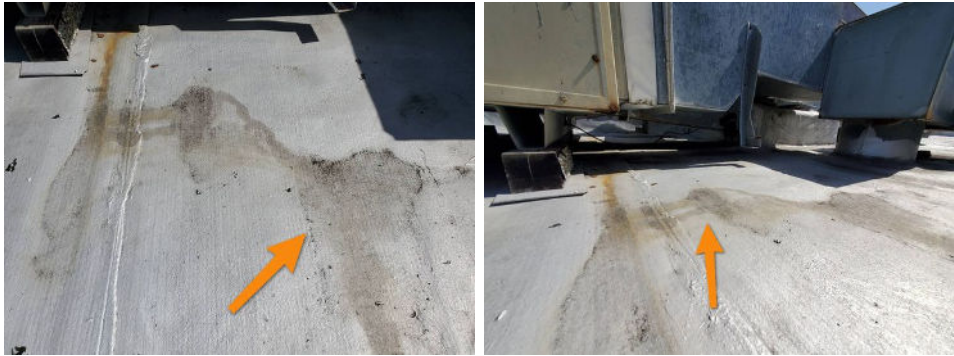
Evidence of ponding in one or more areas of the roof was noted. Ponding can lead to accelerated erosion and deterioration. We recommend adjustment of the slope of the roof at the time re-roofing activities occur.

Recommendation
Contact a qualified roofing professional.

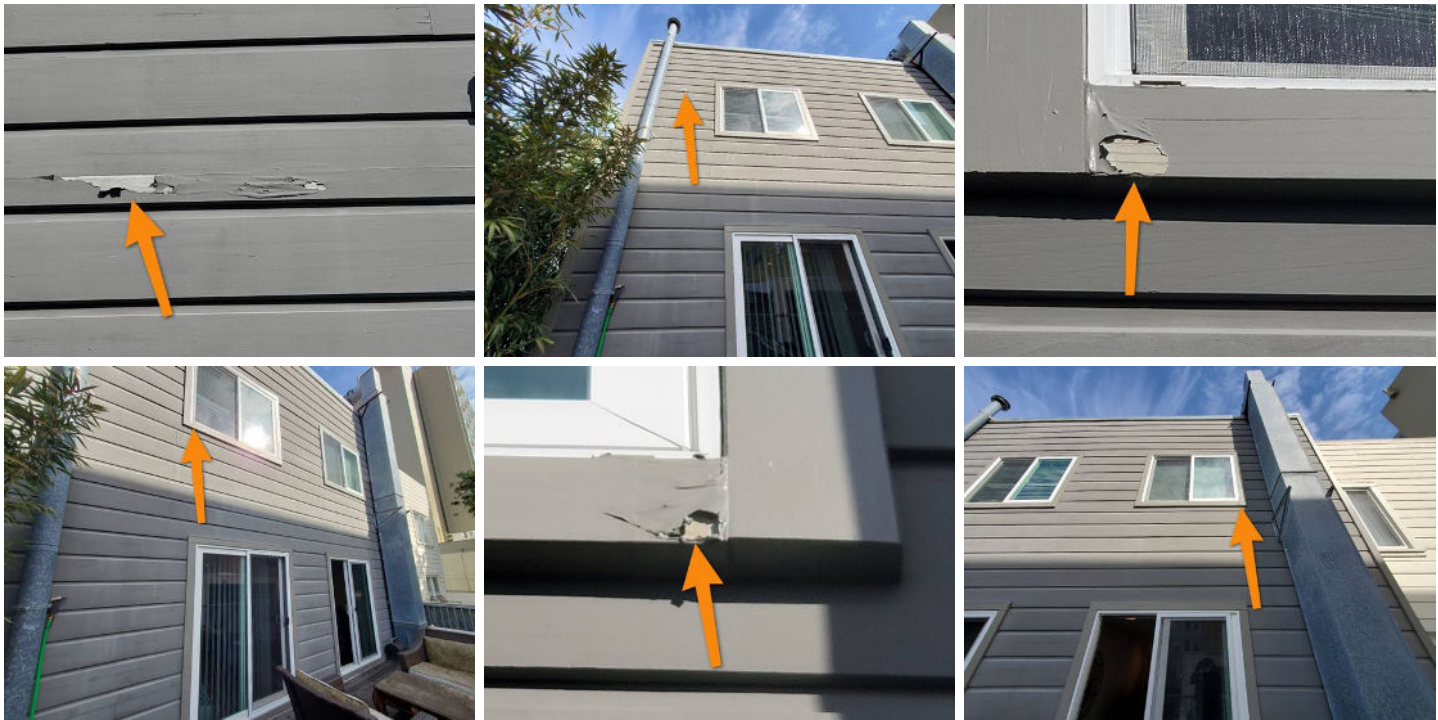
CRACKING, CHIPPED, & MISSING PAINT

Cracking chipped and missing paint at the exterior siding and window trim were noted. We recommend having any missing or chipped paint repainted and properly sealed. This helps to prevent water intrusion and ensure the full waterproofing envelope of the exterior is secure.

Contact a qualified general contractor.

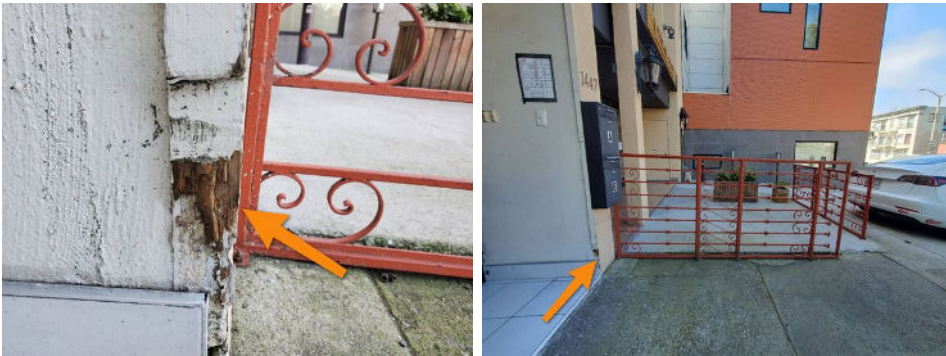
3.3.2 Siding, Flashing & Trim

A damaged trim piece was noted. This could result in moisture intrusion and potential damaging leaks. We recommend contacting a general contractor for repair or recommendation.

Contact a qualified general contractor.

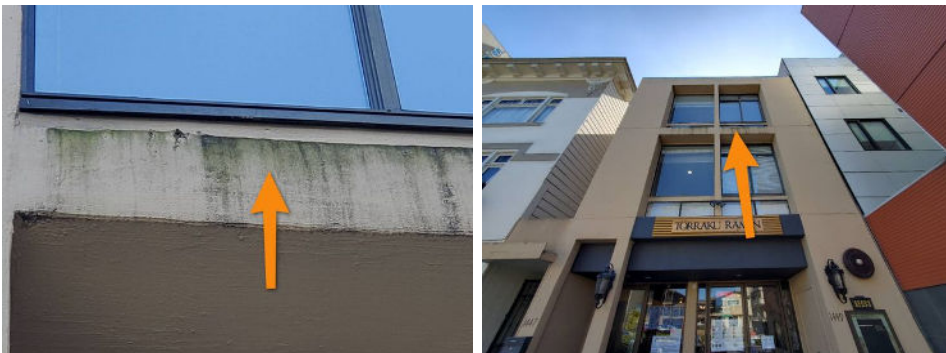
3.3.3 Siding, Flashing & Trim

Fungus was found at the exterior siding. We recommend having these areas washed or cleaned on a regular basis. Moisture can be held inside this material and against the siding and cause damage to the exterior waterproofing membrane.

Contact a qualified general contractor.

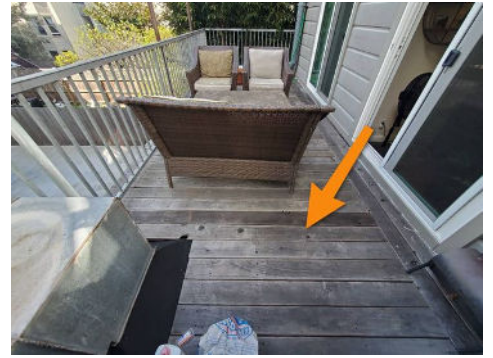
3.6.1 Decks, Balconies, Porches & Steps

Signs of weathering at the decking was noted. Recommend water sealant/weatherproofing be applied to prevent moisture damage. Contact a general contractor for service.

Contact a qualified general contractor.

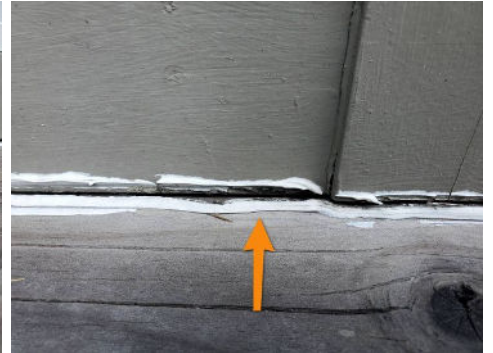
3.6.2 Decks, Balconies, Porches & Steps

Failed and missing sealant was noted at the time of inspection. We recommend resealing under the sliding glass door to prevent moisture intrusion into the home.

Contact a qualified general contractor.

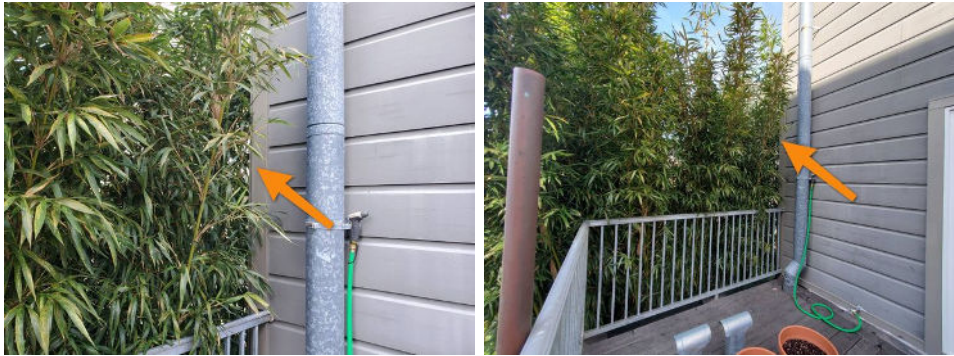
3.7.1 Vegetation, Grading, Drainage & Retaining Walls

Vegetation touching the structure was noted at the time of inspection. This can be a means for pests to access the structure and can cause moisture damage. We recommend contacting a landscape contractor for recommendation and service.

Contact a qualified landscaping contractor

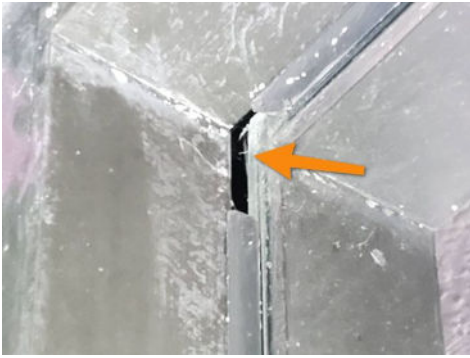
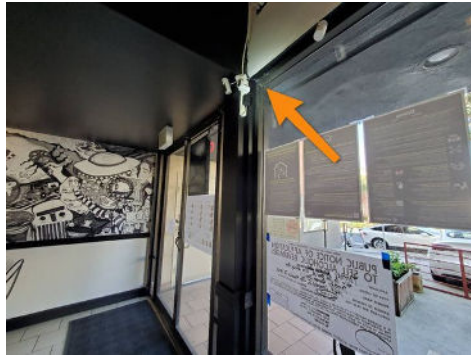
A gap in the weather stripping was noted. This can allow outdoor air/moisture and insects to enter. Contact a licensed window repair and installation contractor for repair.

Contact a qualified window repair/installation contractor.

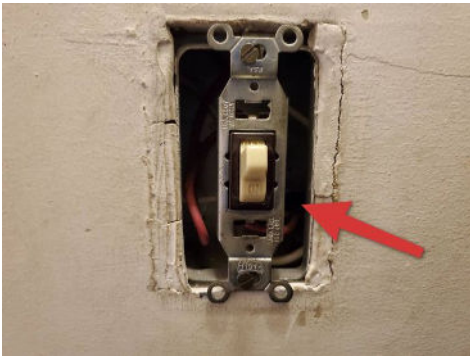
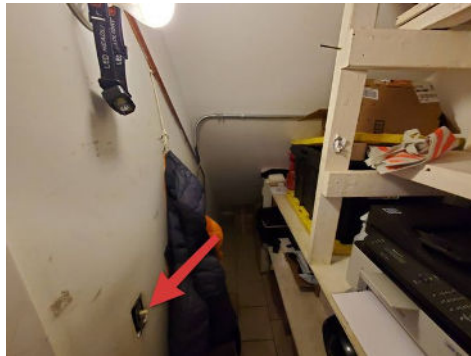
5.7.1 Electrical

A light switch was missing a cover plate inside of the storage closet at the time of inspection. This causes a short circuit and is a shock risk. We recommend having this installed. Contact a licensed electrical contractor for service.

Contact a qualified electrical contractor.

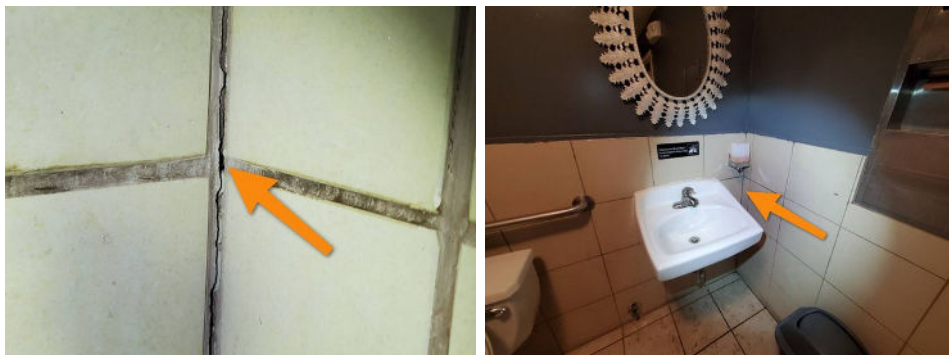
Cracking grout in the wall was noted. This can cause leaks and lead to structural damage. We recommend contacting a tile contractor for further recommendation or service.

Contact a qualified tile contractor

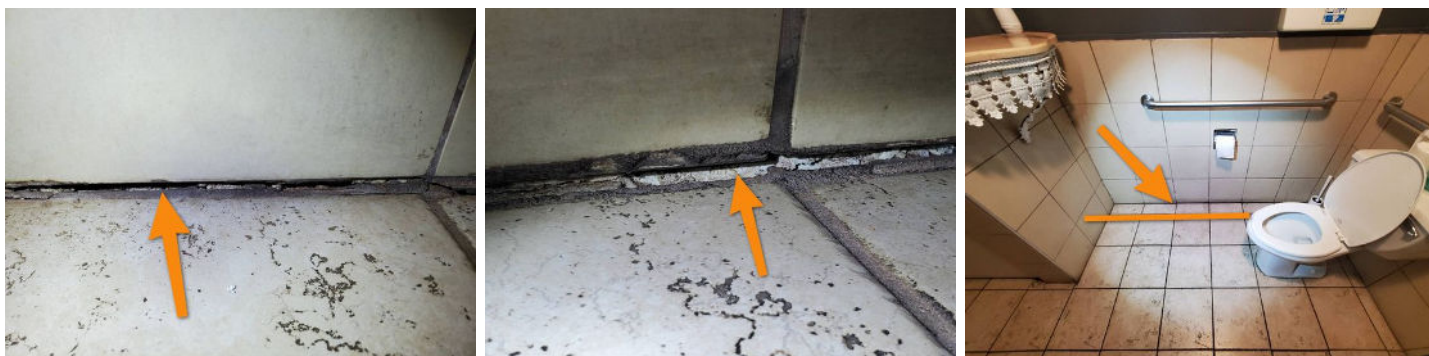
7.6.1 Floors

Separation at the tile-to-wall connection near the toilet was noted. We recommend sealing to prevent moisture damage in case of a toilet leak. Contact a licensed tile contractor for service.

Contact a qualified tile contractor

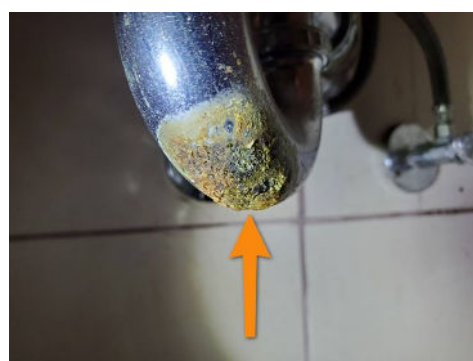
7.10.1 Water Supply, Drainage Systems & Fixtures

Corrosion was noted at the sink drain. This may indicate a leak at the drain line. We recommend contacting a plumbing contractor for service and repair.

Contact a qualified plumbing contractor.

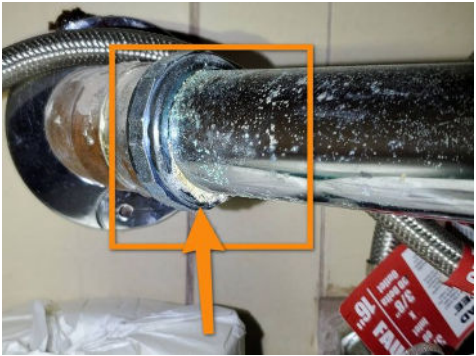
Corrosion was noted at the sink drain. This may indicate a leak at the drain line. We recommend contacting a plumbing contractor for service and repair.

Contact a qualified plumbing contractor.

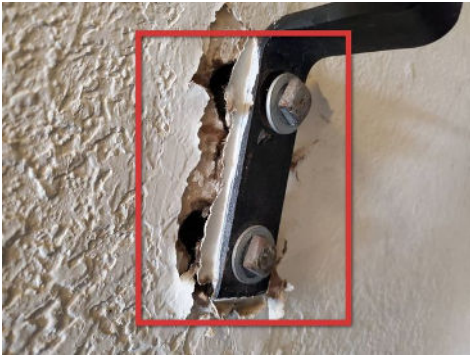
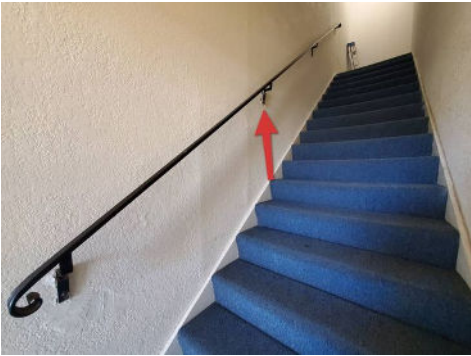
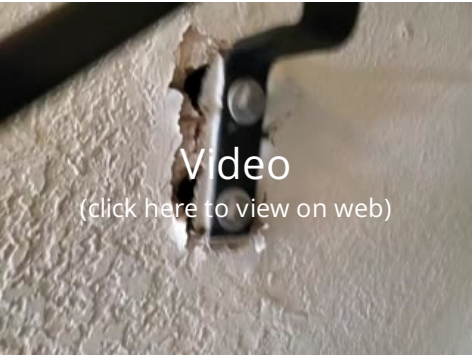
A loose stairway handrail was observed. This is a safety hazard. We recommend repairing by contacting a general contractor for service.

Contact a qualified general contractor.

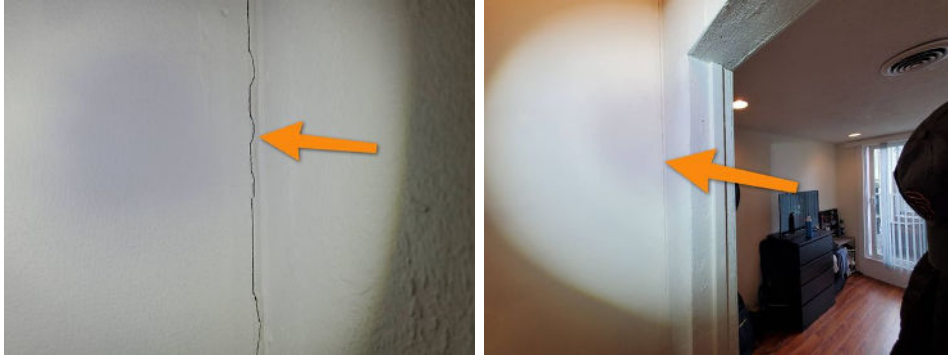
Common thermal expansion cracking in the wall materials was noted. This occurs as materials change in size in response to changes in temperature. These cracks are cosmetic. We recommend contacting a licensed painting contractor for service.

Contact a qualified painting contractor.

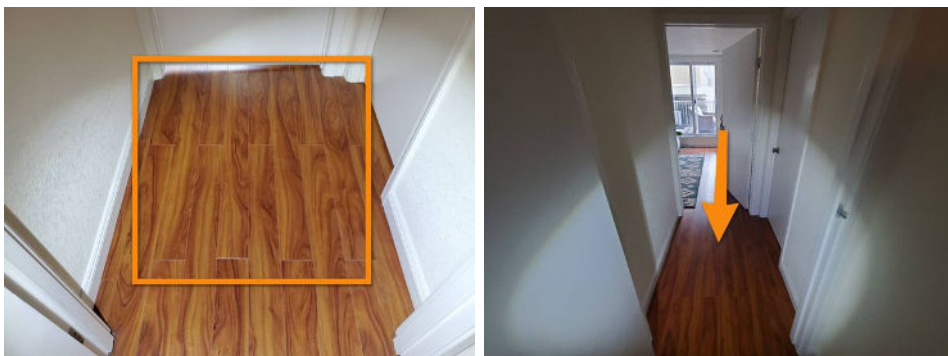
11.5.1 Floors

The laminate flooring appears to have experienced improper acclimation. Floors should be acclimated to the room's humidity and temperature before installation. If the floors do not acclimate properly, they might expand or contract in extreme conditions, resulting in a bouncy floor. Contact a flooring contractor for recommendations.

Contact a qualified flooring contractor

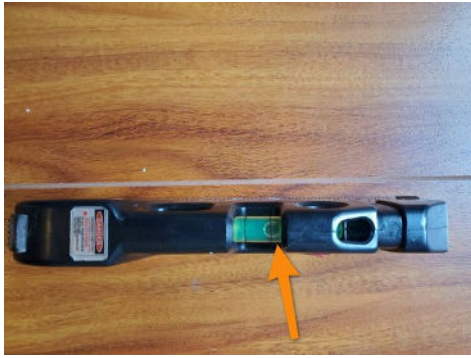
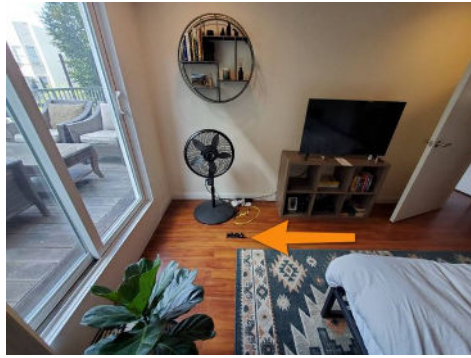
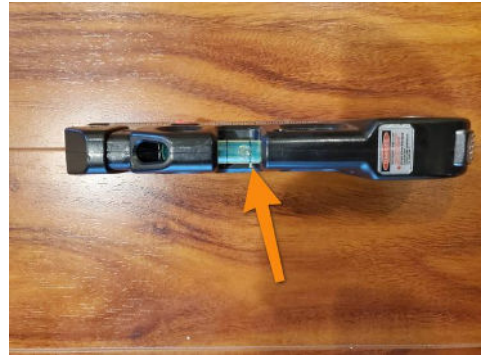
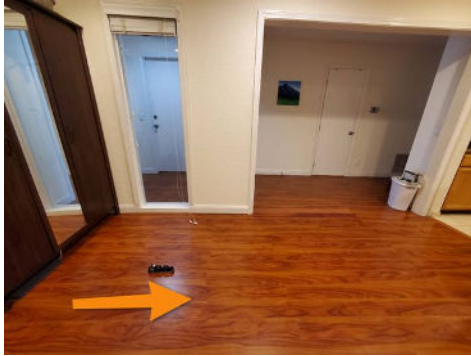
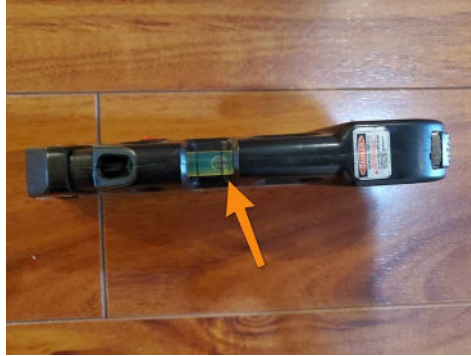
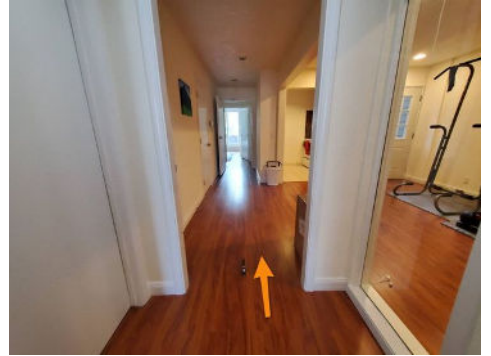
11.5.2 Floors

A floor that was not level was noted in the home. This appears to be caused by long-term structural settling. Contact a licensed general contractor for further recommendation or service in connection to this inspection item.

Contact a qualified general contractor.

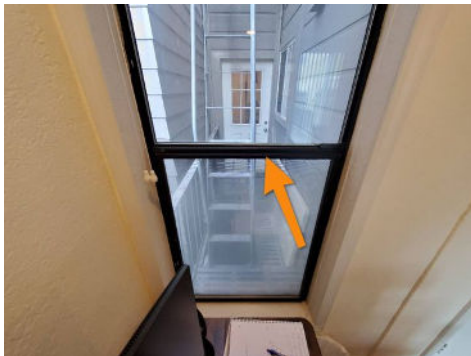
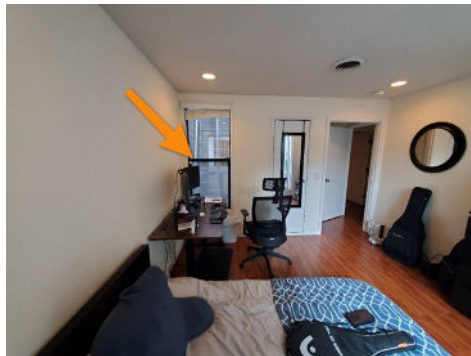
11.6.1 Windows

A window in the home was difficult to open. With the use of force to open or close windows, there's a possibility of breaking the glass pane. We recommend cleaning and lubricating metal hinges. If this doesn't remedy the problem, contact a window repair specialist for service.

Contact a qualified window repair/installation contractor.

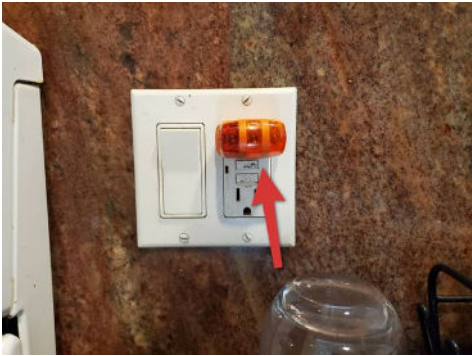
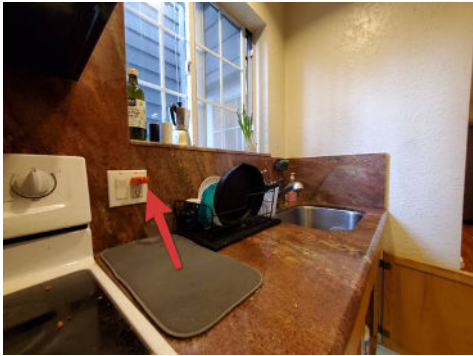
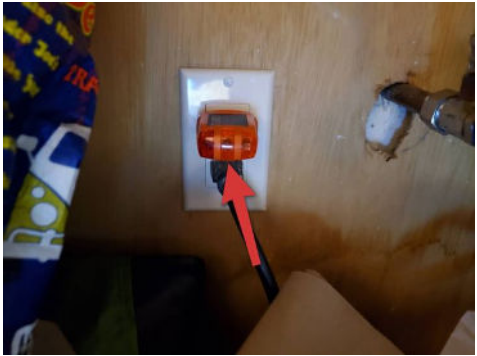
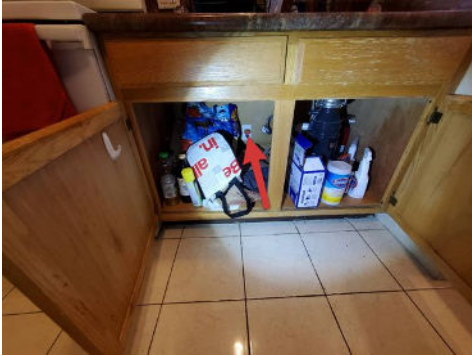
The GFCI receptacles near the stove and under the sink were inoperable at the time of inspection. Contact an electrical contractor for further recommendation or service.

Contact a qualified electrical contractor.

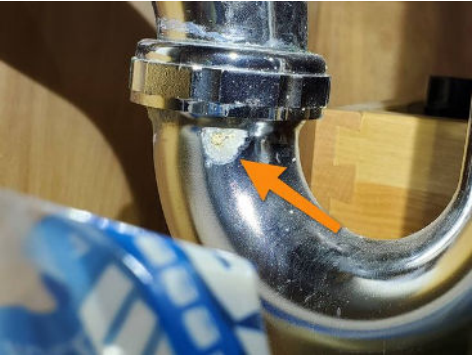
Corrosion was noted at the sink drain. This may indicate a leak at the drain line. We recommend contacting a plumbing contractor for service and repair.

Recommendation
Contact a qualified plumbing contractor.

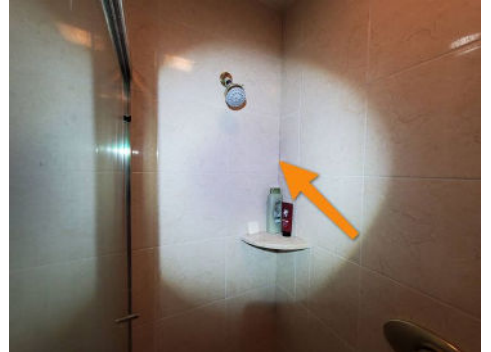
13.12.1 Shower

Cracking grout inside the shower was noted. We recommend repairing with grout or caulking to prevent moisture damage. Contact a licensed tile contractor for further recommendation or service.

Contact a qualified tile contractor

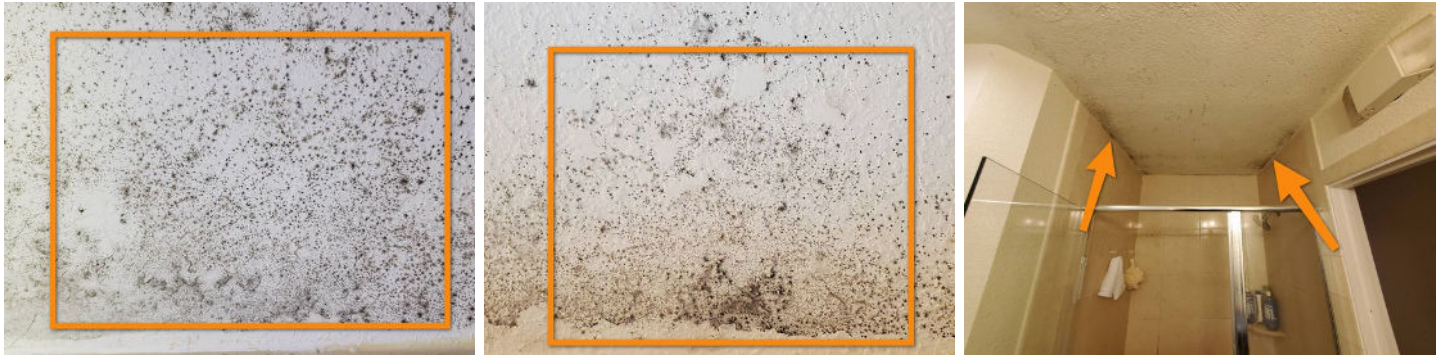
A possible mold-like substance on the bathroom ceiling was noted. Certain types of mold are a life safety hazard. Inadequate ventilation is often a cause of mold-like substances in bathrooms. Contact a licensed mold contractor to send samples to a lab for testing.

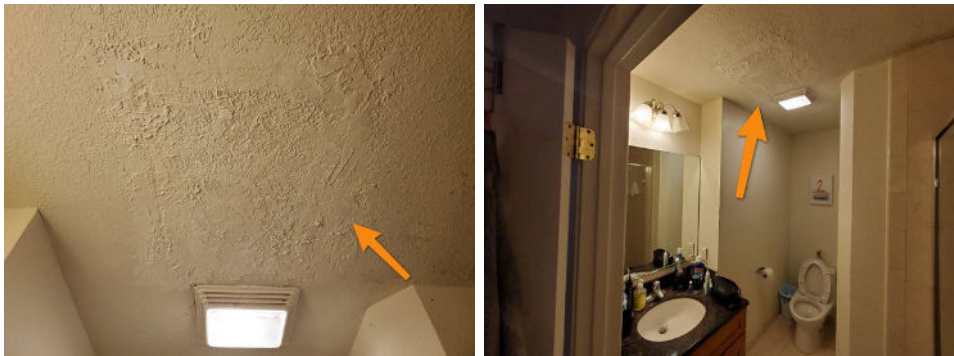
14.4.2 Ceilings

Patching at the ceiling was noted. This patched drywall is cosmetic and not a structural concern. We recommend monitoring and if any signs of moisture begin to show, contact a general contractor for further recommendation or service.

Contact a qualified general contractor.

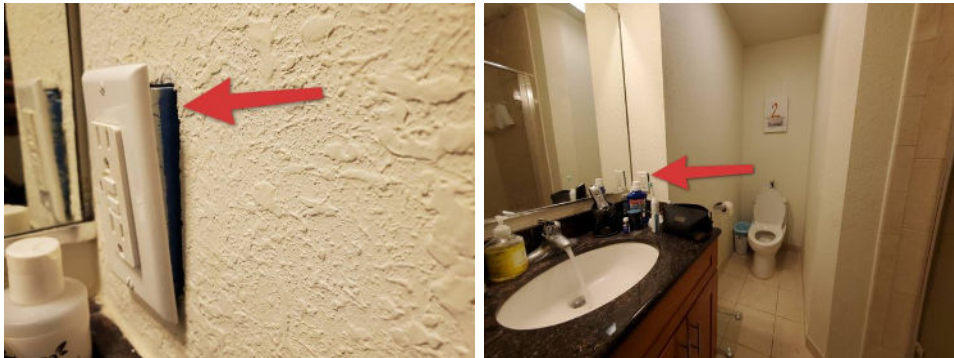
14.9.1 GFCI & AFCI

A loose receptacle inside of the bathroom was noted during the time of inspection. We recommend contacting an electrical contractor for repair.

Contact a qualified electrical contractor.

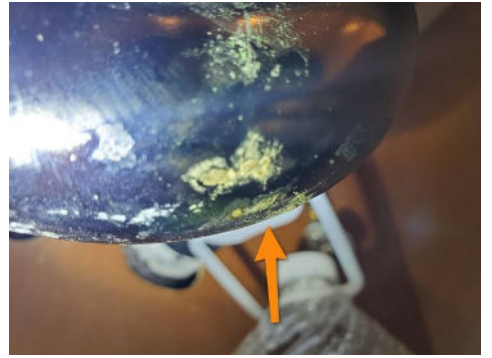
14.10.1 Water Supply, Drainage Systems & Fixtures

Corrosion was noted at the sink drain. This may indicate a leak at the drain line. We recommend contacting a plumbing contractor for service and repair.

Contact a qualified plumbing contractor.

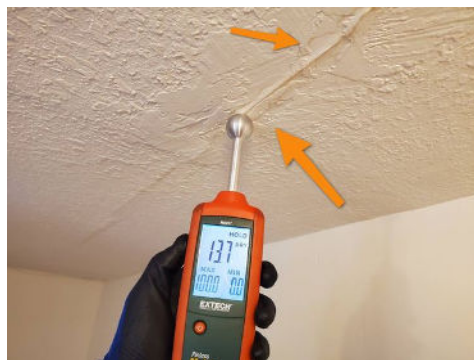
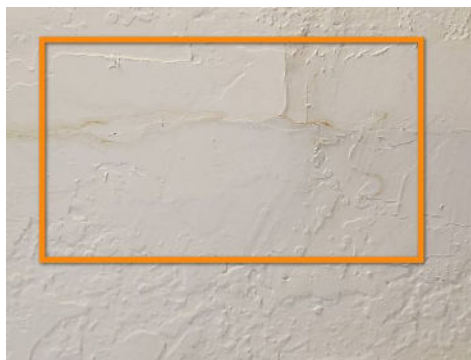
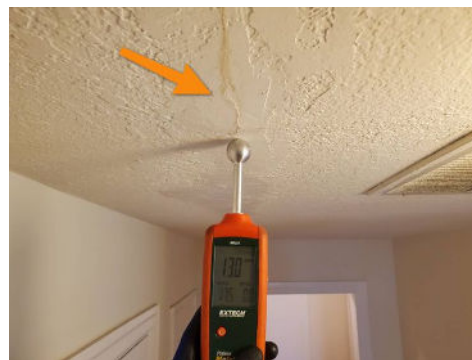
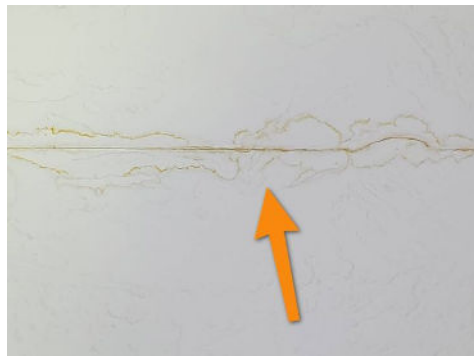
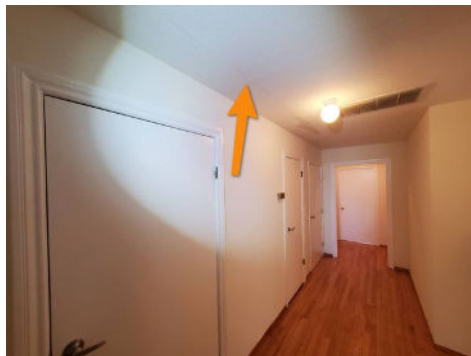
Previous signs of moisture intrusion on the ceiling was noted. The area was dry however, we recommend ensuring the source of moisture intrusion is corrected by contacting a qualified general contractor for further investigation and repair.

Contact a qualified general contractor.

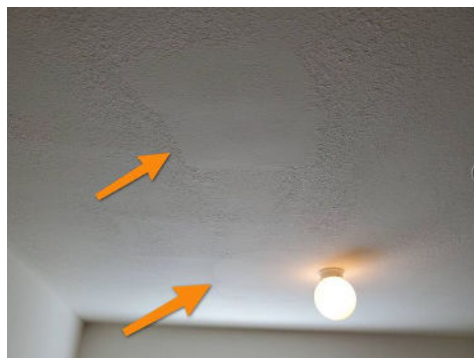
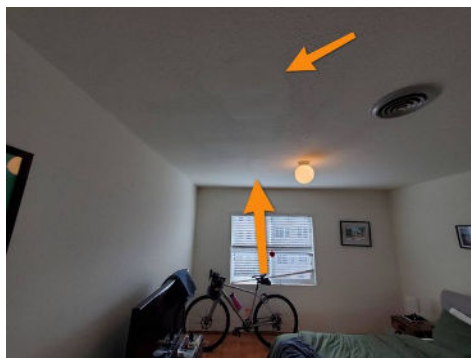
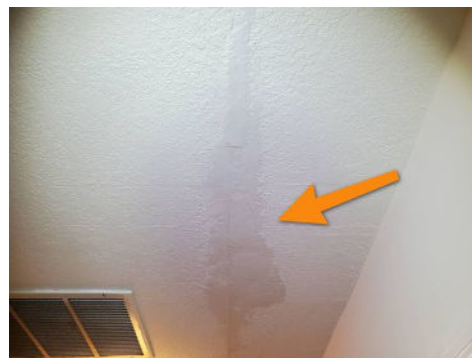
15.3.2 Ceilings

Sub-standard patching was noted. This patched ceiling is cosmetic and does not appear to be a structural concern. We recommend monitoring these areas, and should there be any signs of moisture that appear, we suggest contacting a general contractor for further recommendation or service.

Contact a qualified general contractor.

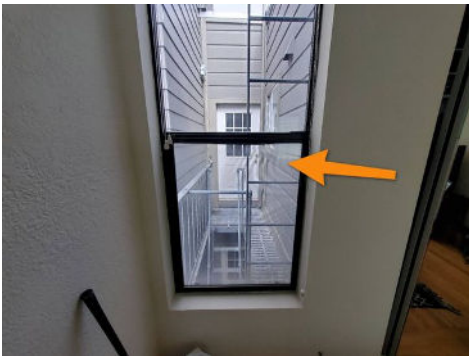
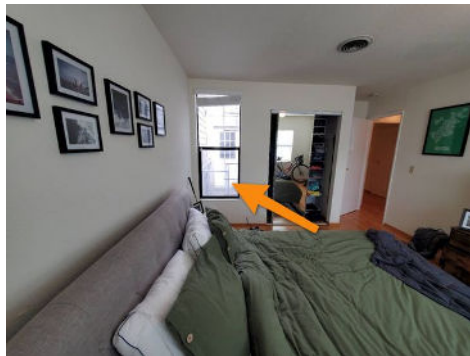
15.6.1 Windows

A window in the home was difficult to open. With the use of force to open or close windows, there's a possibility of breaking the glass pane. We recommend cleaning and lubricating metal hinges. If this doesn't remedy the problem, contact a window repair specialist for service.

Contact a qualified window repair/installation contractor.

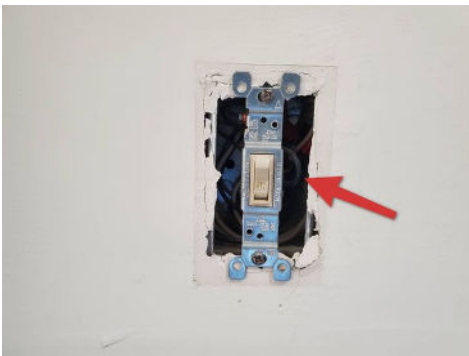
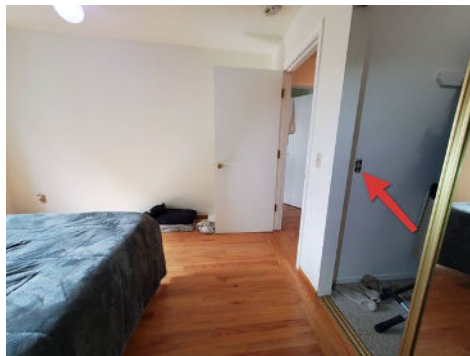
15.8.1 Electrical

A light switch was missing a cover plate at the time of inspection. This causes a short circuit and is a shock risk. We recommend having this installed by contacting a licensed electrical contractor for service and repair.

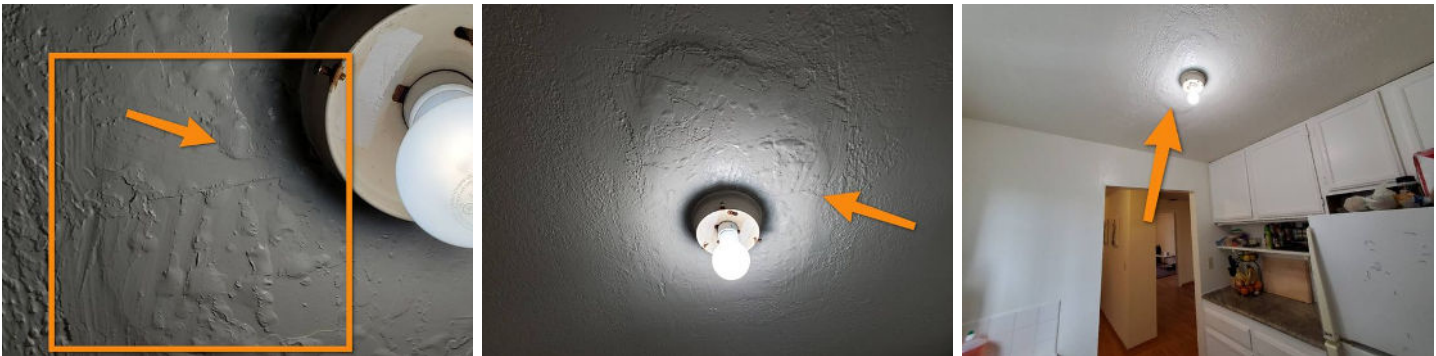
Visible bubbling at the ceiling was noted. This could possibly be caused by a change in the temperature and humidity causing the area to reach high moisture levels. We recommend contacting a general contractor for further recommendation or service.

Contact a qualified general contractor.

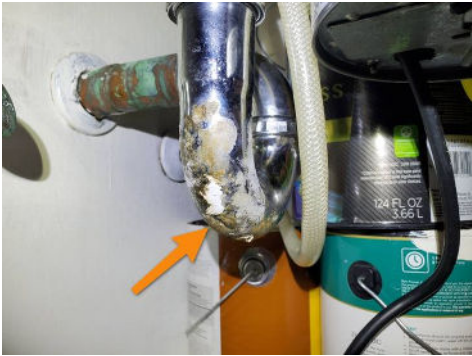
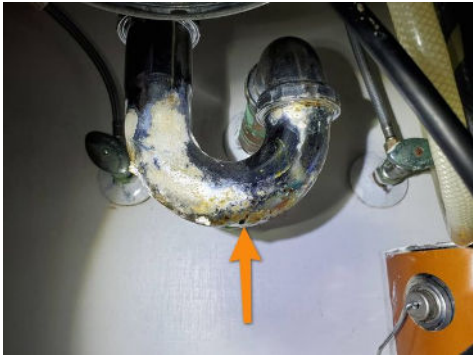
16.10.1 Water Supply, Distribution Systems & Fixtures

Corrosion at the sink drain was noted. This may indicate a leak at the drain line. Contact a plumbing contractor for service and repair.

Contact a qualified plumbing contractor.

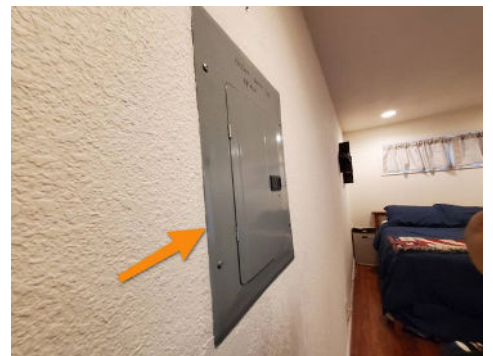
The electrical panel was painted-sealed to the wall. Recommend licensed electrician further examine subpanel.

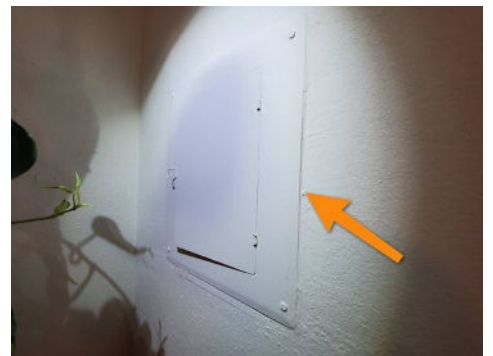
Unit B - Branch Wiring Circuits, Breakers & Fuses

The electrical panel was painted-sealed to the wall. Recommend licensed electrician further examine subpanel.

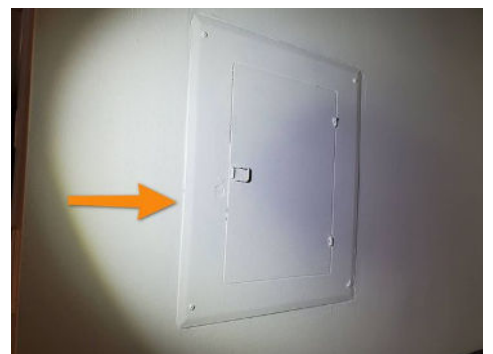
Restaurant - Subpanel #3 - Branch Wiring Circuits, Breakers & Fuses

The electrical panel was painted-sealed to the wall. Recommend licensed electrician further examine subpanel.

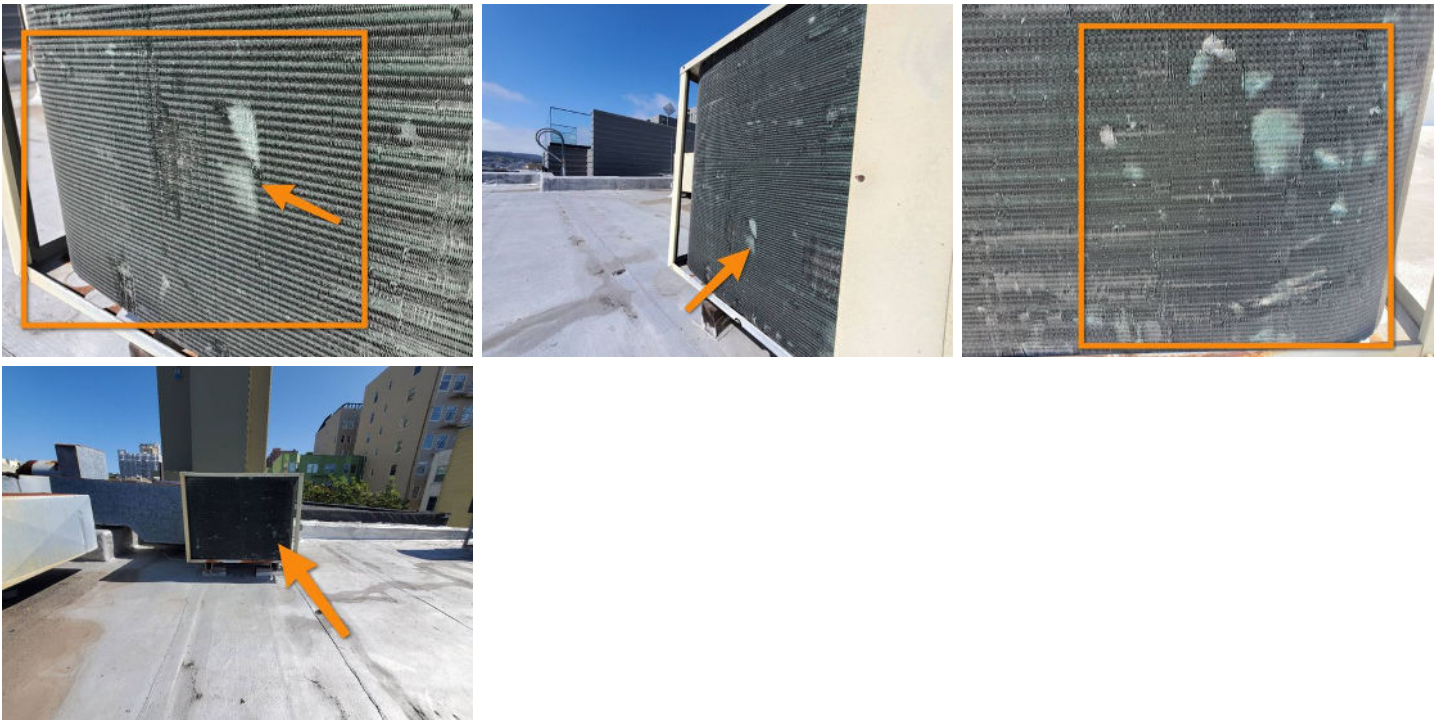
Dented fins at the air conditioning unit were noted. This is typically caused by pressure washing, hail, and tree debris. The unit was functional at the time of inspection, but may be beyond normal useful life. Contact an HVAC contractor for service.

Recommendation
Contact a qualified HVAC professional.
