GOLDEN GATE HOME INSPECTIONS

HOME INSPECTION REPORT

1234 Main Street
San Francisco, CA 94111

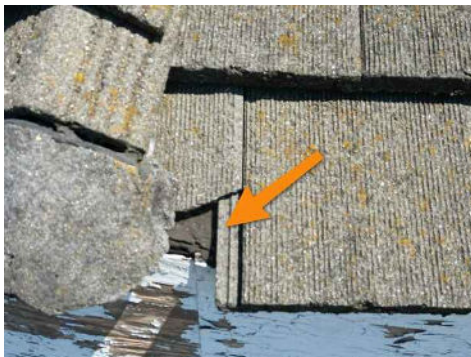
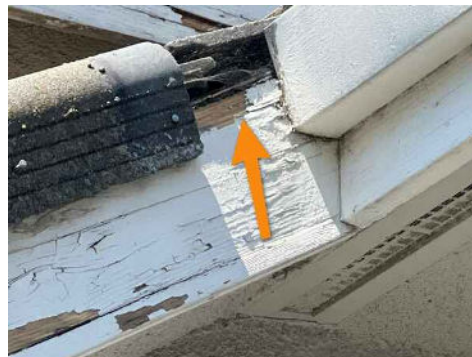
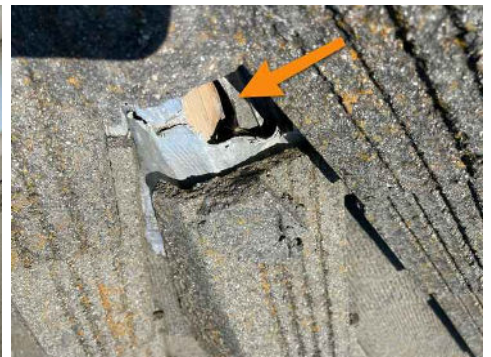
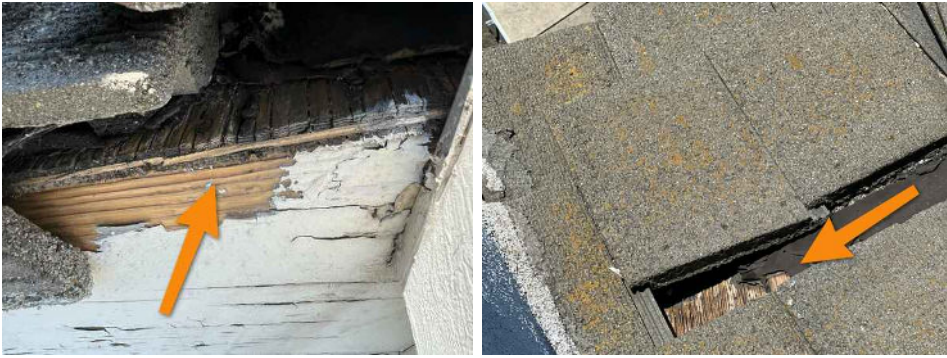
2.2.1 Coverings

DAMAGED UNDERLAYMENT VISIBLE

Areas of damaged wood underlayment were visible in areas of the roofing materials. This means that the roof is open to moisture intrusion. We recommend a roofing contractor evaluate.

Contact a qualified roofing professional.

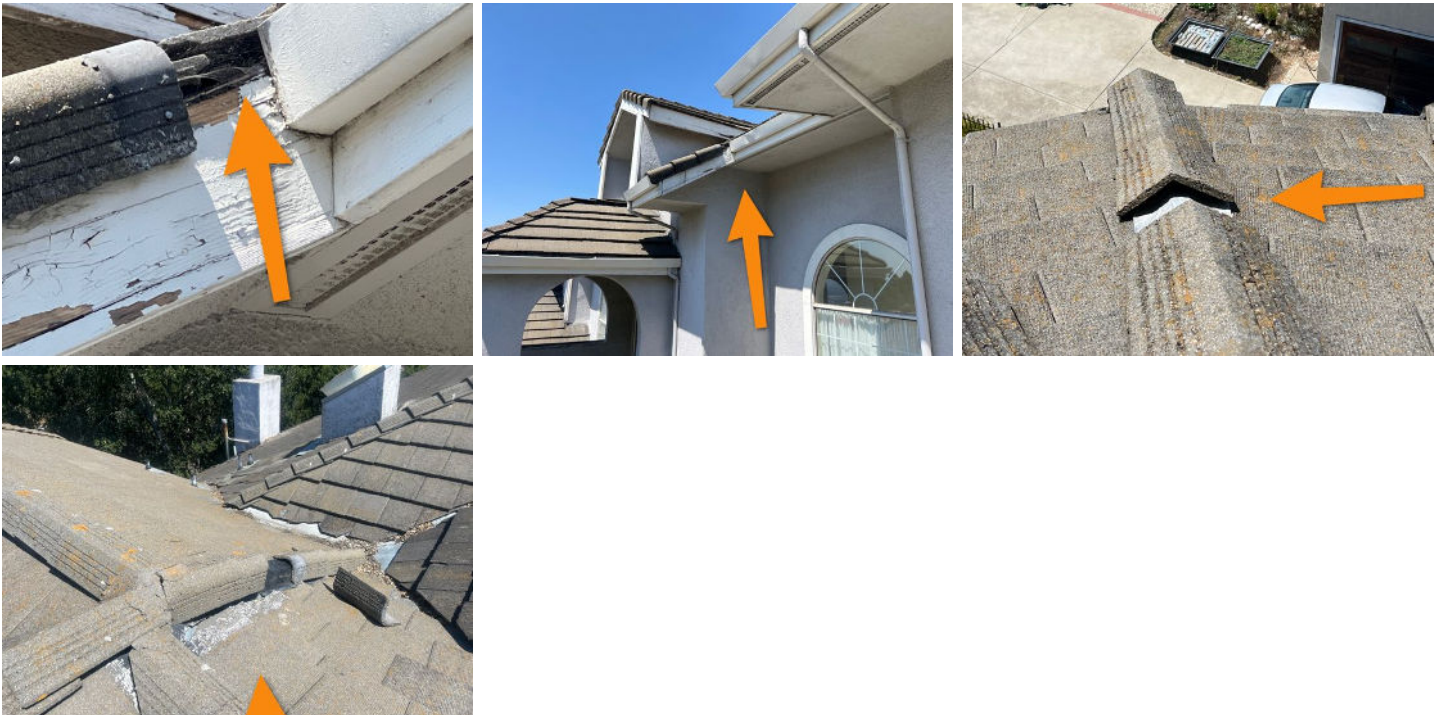
2.2.2 Coverings

SHINGLES MISSING

Observed areas that appeared to be missing sufficient coverings were noted. Recommend qualified roofing contractor evaluate & repair.

Contact a qualified roofing professional.

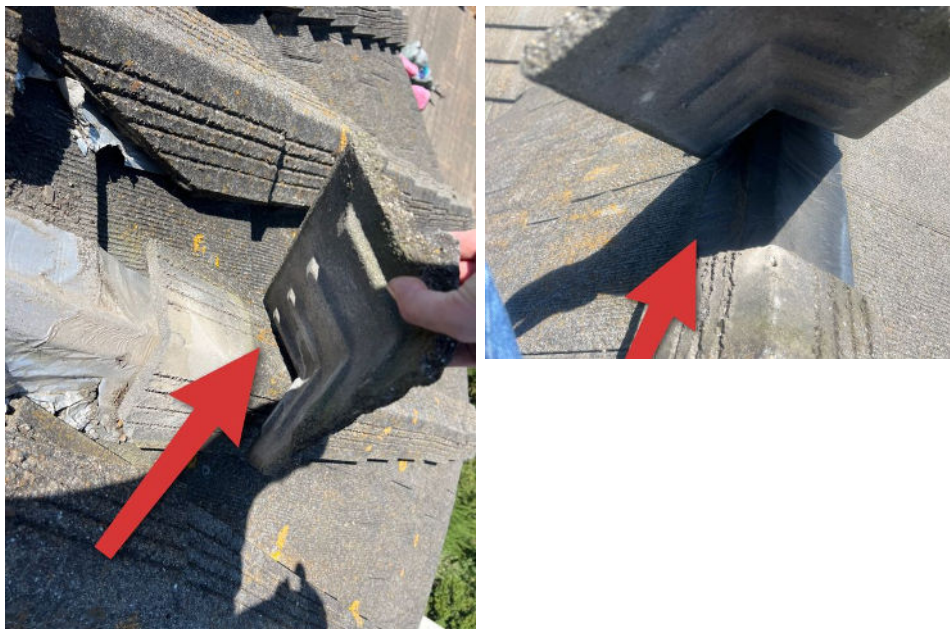
2.2.3 Coverings

LOOSE TILES

Loose tiles and nails noted on the edge of the roof. Recommend repairing these as they can be a safety hazard if they fall.

Contact a qualified roofing professional.

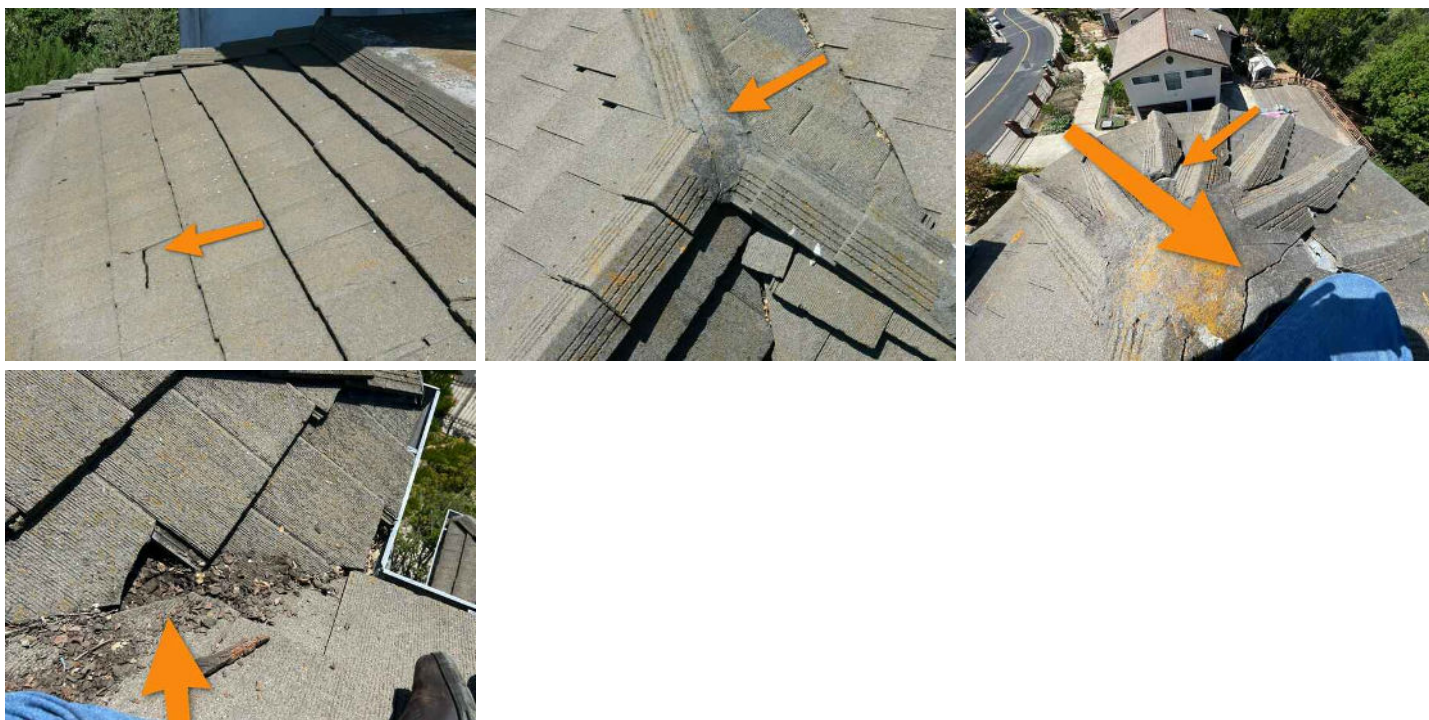
2.2.4 Coverings

TILES CRACKED/BROKEN

Cracked/broken tiles at the roof were noted. Consider having corrected to prevent moisture intrusion.

Contact a qualified roofing professional.

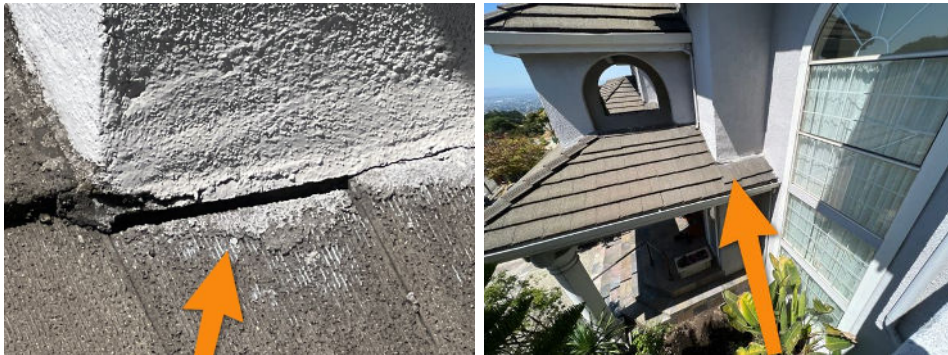
2.3.1 Flashings

LOOSE/SEPARATED FLASHING

Loose or separated flashing, improperly installed flashing, or gaps in the roofing system noted. This can lead to water intrusion and damaging leaks. Consider having corrected to secure the waterproofing envelope of the exterior.

Contact a qualified roofing professional.

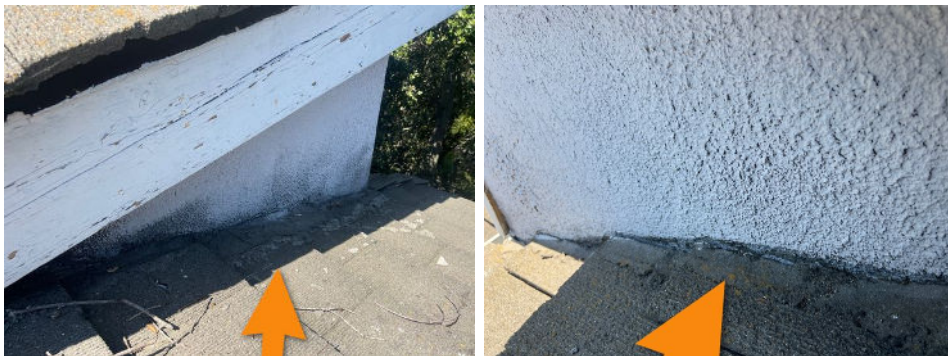
2.3.2 Flashings

MISSING SIDEWALL GAP

In both headwall and sidewall conditions, unless the exterior wall is brick, you should see a gap of at least 1½ inches between the bottom of the exterior wall-covering material and the top of the roof-covering material. Without a gap, the exterior wall covering can wick up moisture from the roof. This can lead to decay, delamination, peeling paint, and other problems. We recommend contacting a roofing contractor for recommendation and service.

Contact a qualified roofing professional.

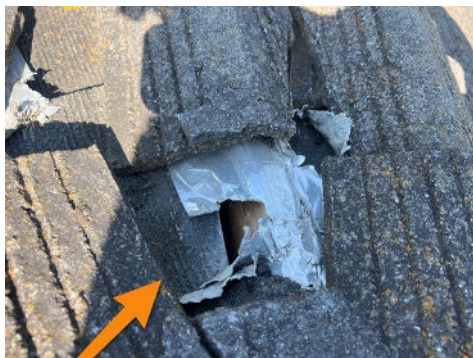
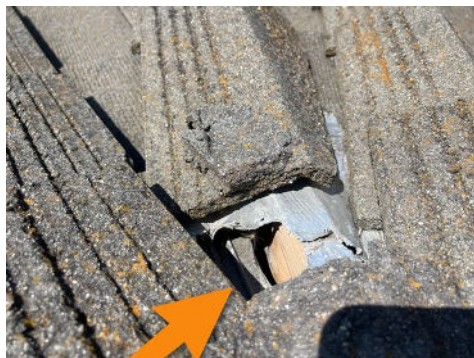
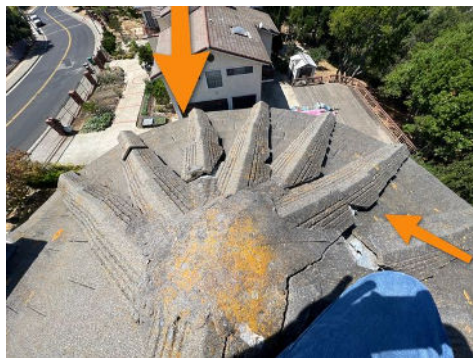
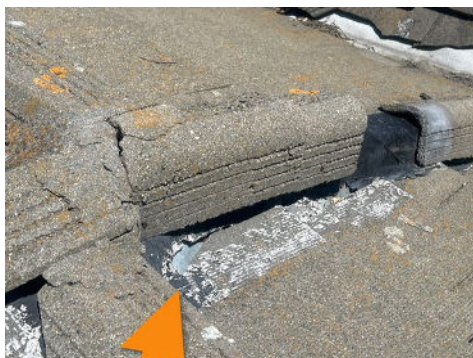
2.3.3 Flashings

FLASHING DAMAGED

Damage to flashing was noted on the roof. We recommend further assessment by a roofing contractor to assure viability.

Contact a qualified roofing professional.

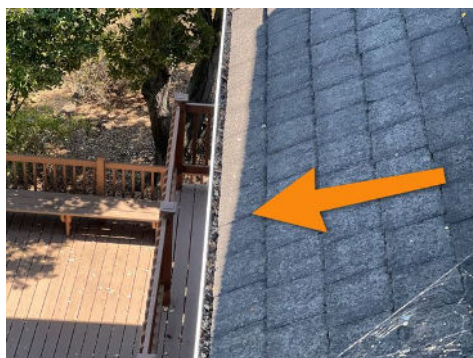
2.4.1 Roof Drainage Systems

DEBRIS

Accumulated debris at gutters and/or scuppers noted. We recommend removing debris to ensure proper drainage of the roofing system and to prevent moisture damage.

Contact a qualified gutter contractor

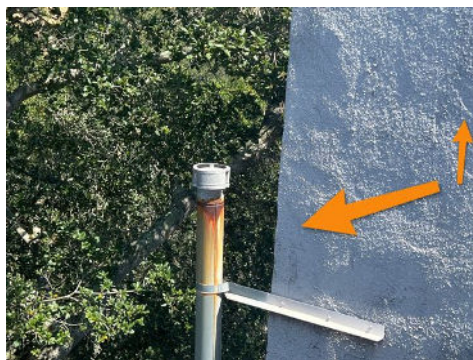
2.5.1 Skylights, Chimneys & Other Roof Penetrations

RUSTED ROOF PENETRATION

A rusted roof penetration was noted. Rusted roof penetrations can cause eventual moisture damage. We recommend contacting an HVAC contractor for further recommendation or service.

Contact a qualified HVAC professional.

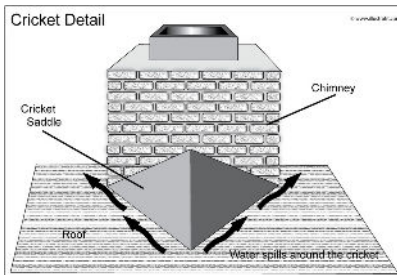
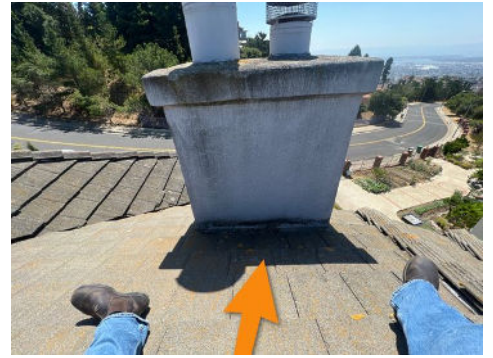
2.5.2 Skylights, Chimneys & Other Roof Penetrations

CHIMNEY CRICKET NOT INSTALLED

A chimney cricket was not installed at the time of inspection. Chimney width was 4'2 inches. Chimneys over 36 inches wide create a water trap and potential point of moisture intrusion if there is not a chimney cricket to divert water. Contact a roofing contractor for evaluation and correction.

Recommendation
Contact a qualified roofing professional.

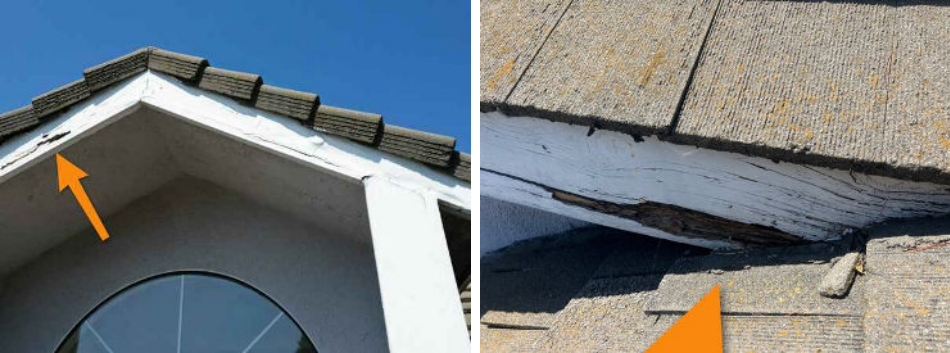
3.1.1 Eaves, Soffits & Fascia

DRY ROT

Visible dry rot at eaves was noted. Roof and/or gutters may be leaking causing these eaves to absorb moisture and causing dry rot. We recommend locating the cause and correcting it before further damage occurs.

Recommendation
Contact a qualified general contractor.

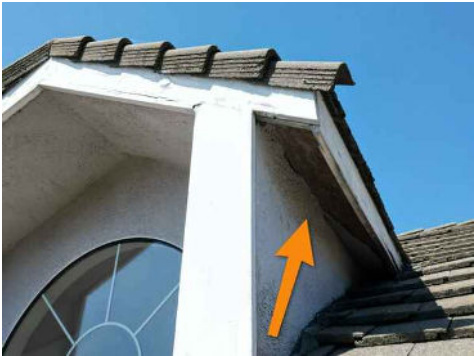
3.1.2 Eaves, Soffits & Fascia

SOFFITS - WATER STAINS

Water stains at the soffits were noted. This may indicate an active leak. We recommend locating and eliminating the source of moisture. Further investigation is needed. Contact a general contractor for repair options.

Recommendation
Contact a qualified general contractor.

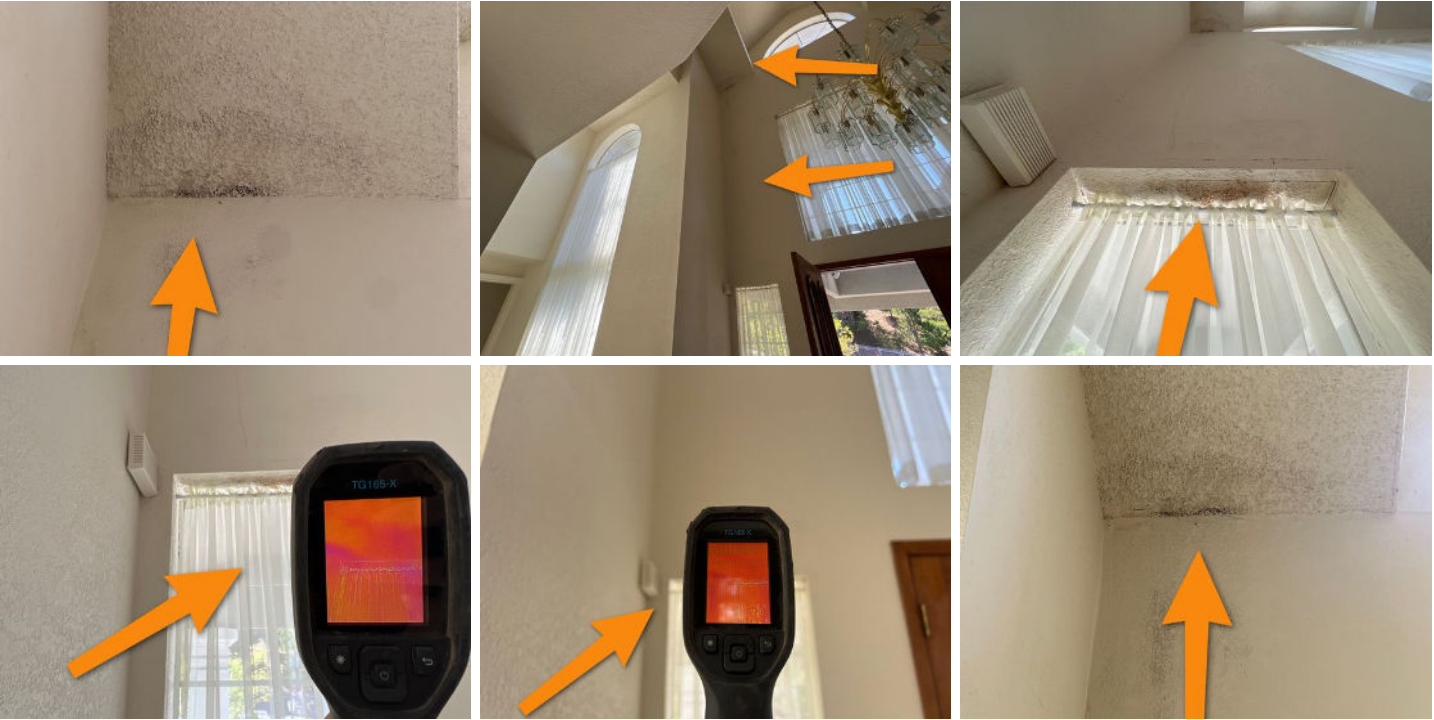
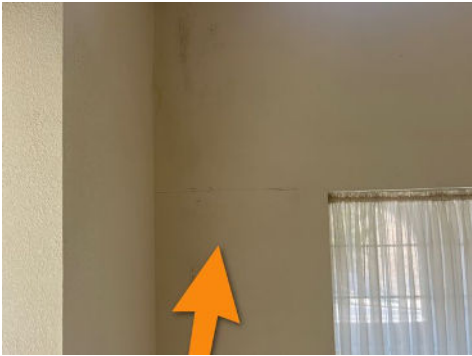
4.1.1 Ceilings

PREVIOUS MOISTURE INTRUSION

Stains to ceiling materials from prior moisture intrusion were noted. There were no apparent signs of moisture at the time of the inspection. We recommend monitoring these areas periodically for leaks and contacting a qualified roofing contractor if this occurs.

Contact a qualified general contractor.
