GOLDEN GATE HOME INSPECTIONS

HOME INSPECTION REPORT

1234 Main St. El Cerrito CA 94530

12/13/2020 9:00AM

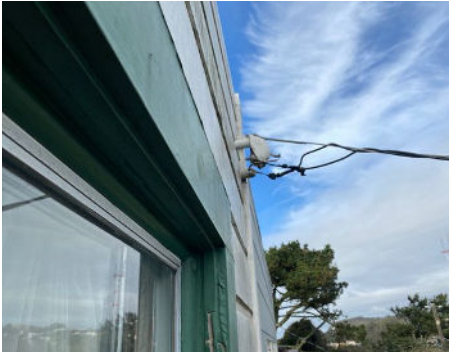
Service Entrance Conductors: Service Mast

The overhead service mast is located on the left side of the garage door. The masthead, drip loop and mast support appeared to be in good condition.

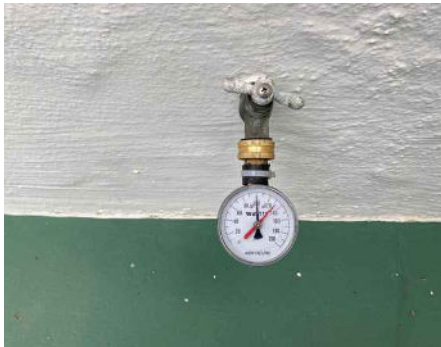
General: Water Pressure

Water pressure was adequate at 60 psi.
